Town of Petrolia

Bright's Grove Water Treatment Plant Intake Replacement

Class Environmental Assessment Project File Report

T001646A

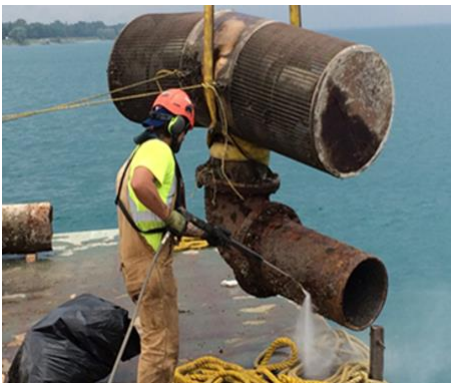
Figure 5-2: Intake Screen

In 2017, the existing intake screen was removed for inspection and cleaning and was found to be in very poor condition with zebra mussels attached to the outer surface (Figure 5-2). During the inspection, a six-meter section of the 400 mm (16 inch) diameter cast iron intake pipe was found to be damaged at the screen connection. The damaged pipe section was removed and replaced with a new section of pipe and repair coupling. Once removed, the section of pipe removed was found to be infested with zebra mussels (Figure 5-3 and Figure 5-5), reducing the inside diameter of the pipe by approximately 40% (from 400 mm to 250 mm). The reduced cross section of the intake pipe, combined with the increased roughness of the pipe walls, has resulted in higher head losses through the intake pipe which has resulted in cavitation at the low lift pumps. Cavitation at the pumps has resulted in significant damage to the low-lift pumps (Figure 5-4). In 2018, the entire length of the intake pipe was high-pressure washed at 14,000 kPa (2000 psi) to remove sediments (sand) and zebra mussels in the intake. An ROV camera inspection completed afterwards revealed the zebra mussel infestation remained present in over 75% of the entire length of the intake pipe. During the inspection, in addition to the partial intake blockage due to zebra mussels, the pipe was determined to be significantly corroded, a 1.2 m long crack was observed along the bottom third of the pipe near the shoreline (Figure 5-6) and an old isolation valve was found to be inoperable and partially closed blocking 25% of the inside diameter of the intake pipe. Finally, the presence of the zebra mussels within the intake pipe has resulted in shells being conveyed to the intake screens which has resulted in rapid clogging of the screens and increased needs for backwashing (Figure 5-7).

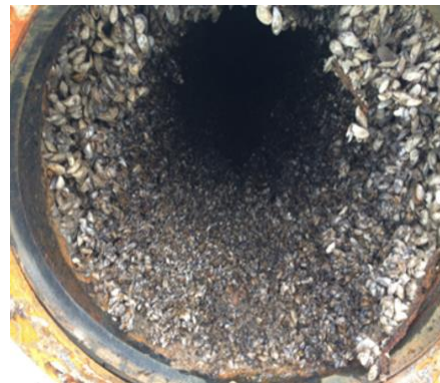
Figure 5-3: Zebra Mussel Infestation

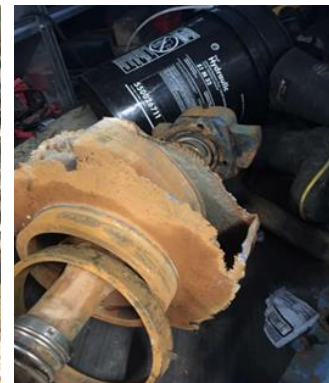
Figure 5-4: Damaged Impeller

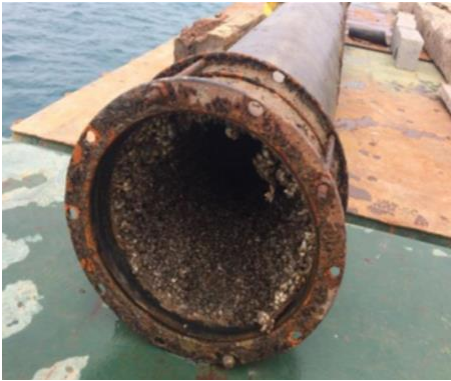
Figure 5-5: Zebra Mussels Infestation

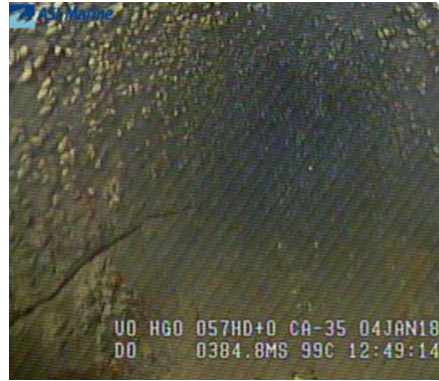
Figure 5-6: Cracked Intake

Winter 2017/2018	Pressure washing intake	<ul style="list-style-type: none"> Galcon Marine was retained to clean the intake and to remove the zebra mussel layer inside the intake. The entire length of intake was high pressure washed at 13,780kPa (2,000 psi). An ROV camera inspection was conducted by ASI Marine to assess the results of the cleaning. The zebra mussel layer was still partially present, covering approximately the top half of the inside diameter a few meters from the newly installed pipe at the intake elbow. The bottom third of the inside diameter was not covered with zebra mussels, which suggests that the bottom half of the intake was likely covered with sand. The majority of inside the intake was observed to be spotted with some corrosion identified as iron tuberculation. During the cleaning a horizontal crack approximately 2m long was observed just below the springline of the pipe, approximately 167m from the WTP. The crack is not considered to pose an imminent risk; however, it is indicative of the overall condition of the aging pipeline.

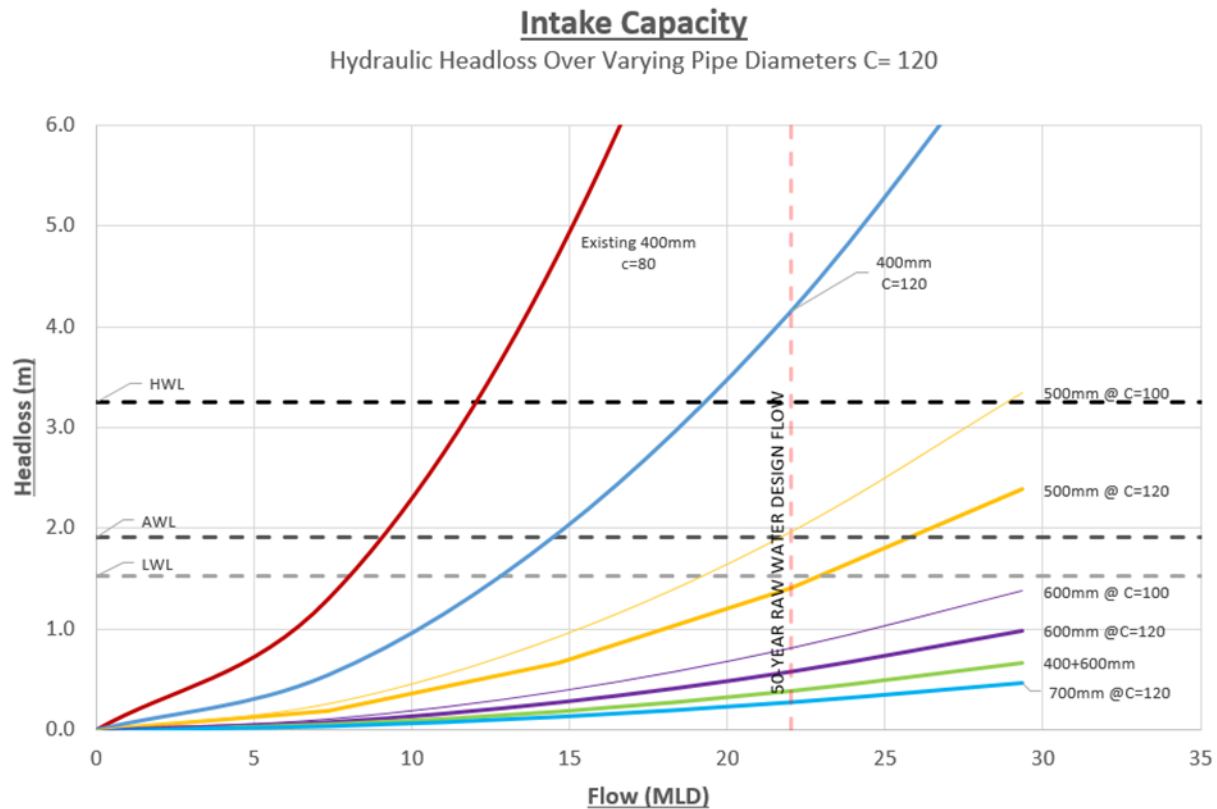
Figure 6-1: Intake Capacity at Varying Pipe Sizes

Preliminary pipe sizes using the Hazen-Williams equation are plotted to determine the minimum pipe size for the 50-year design flow as shown in Figure 6-1.

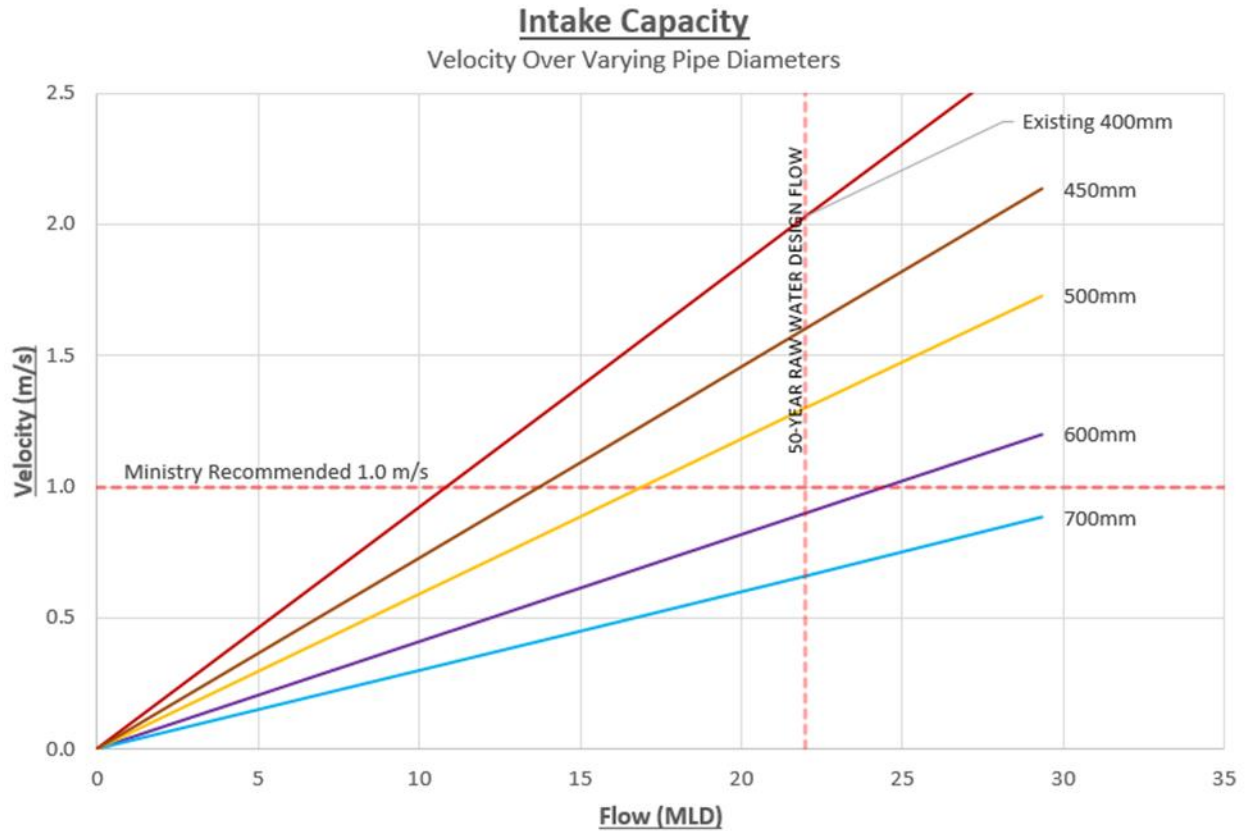
Figure 6-2: Water Velocity Over Varying Pipe Diameters

The following Figure 6-2 shows the water velocities over the ranging pipe diameters and how it compares to the Ministry's guideline.

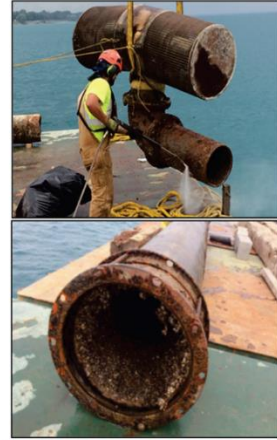
Photos taken of intake screen, pipe cut-out section, zebra mussel infestation, pipeline crack near the shoreline.

- Existing intake pipe:
 - Installed in 1944 to replace the original intake pipeline constructed in 1896.
 - Extends approximately 400m into Lake Huron.
 - 400mm diameter cast iron pipe.
 - Equipped with an intake screen to allow water flow into the pipe and crib structure to protect the screen.
 - Recently retrofitted with zebra mussel and frazil ice control systems.
- **Intake pipe is at the end of its useful life.** Its current condition results in hydraulic capacity limitations, maintenance concerns resulting in risk of failure.
- Expected capital costs are \$16.2Million.

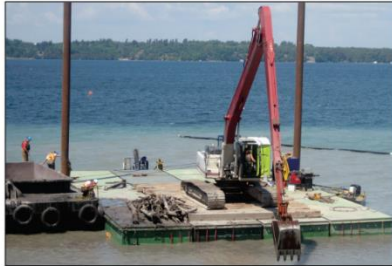
Excavation of marine trench with floating dredging equipment

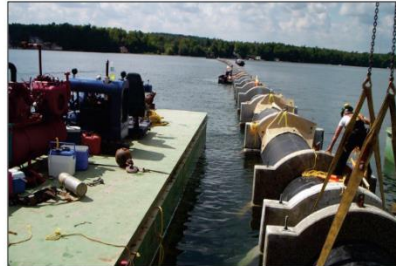
Installation of intake pipeline with ballast to prevent pipeline from floating

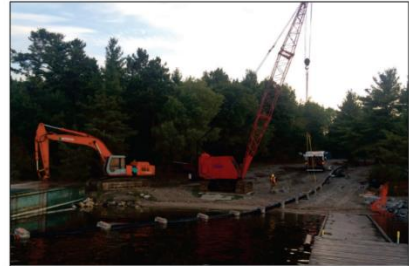
Onshore installation of intake pipeline

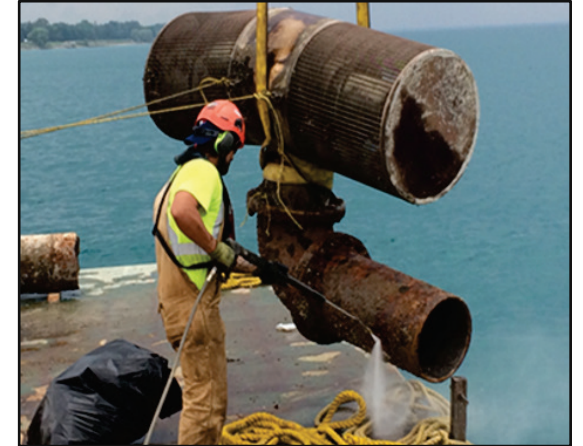
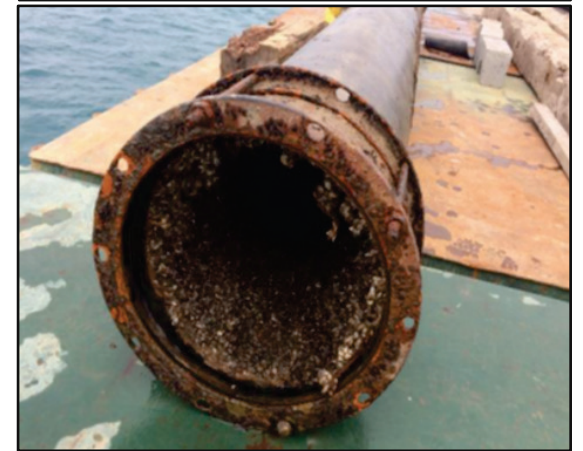
Photos taken of intake screen, pipe cut-out section, zebra mussel infestation, pipeline crack near the shoreline.

- Existing intake pipe:
 - Installed in 1944 to replace the original intake pipeline constructed in 1896.
 - Extends approximately 400m into Lake Huron.
 - 400mm diameter cast iron pipe.
 - Equipped with an intake screen to allow water flow into the pipe and crib structure to protect the screen.
 - Recently retrofitted with zebra mussel and frazil ice control systems.
- **Intake pipe is at the end of its useful life.** Its current condition results in hydraulic capacity limitations, maintenance concerns resulting in risk of failure.
- Expected capital costs are \$16.2Million.

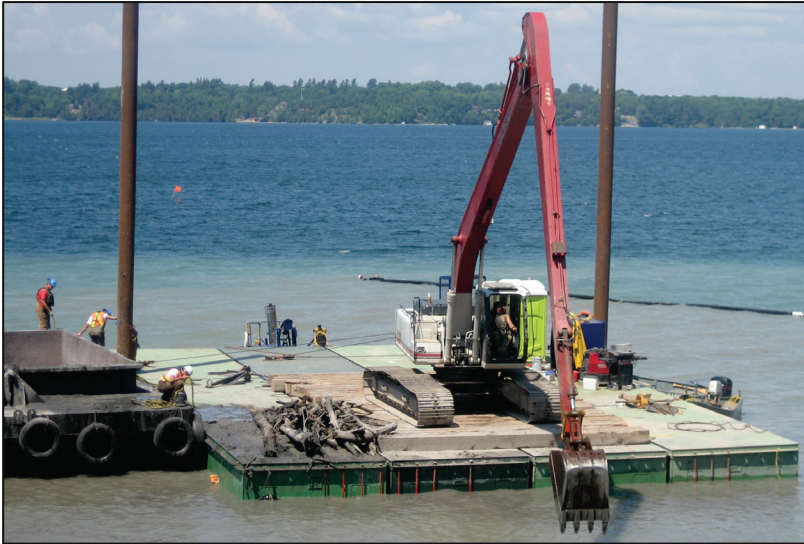
Excavation of marine trench with floating dredging equipment

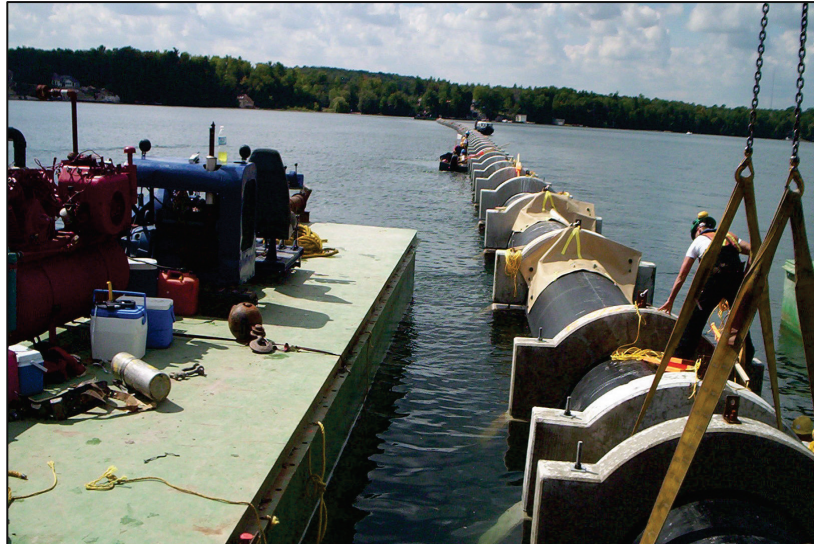
Installation of intake pipeline with ballast to prevent pipeline from floating

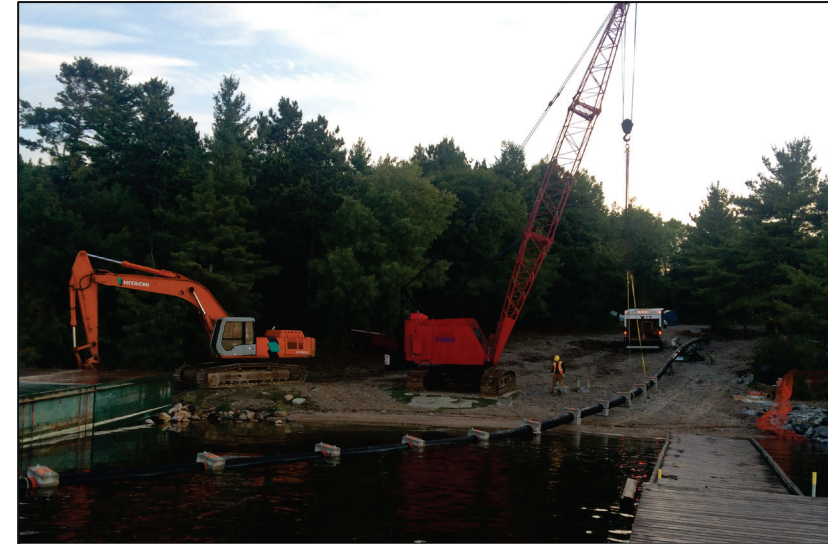
Onshore installation of intake pipeline

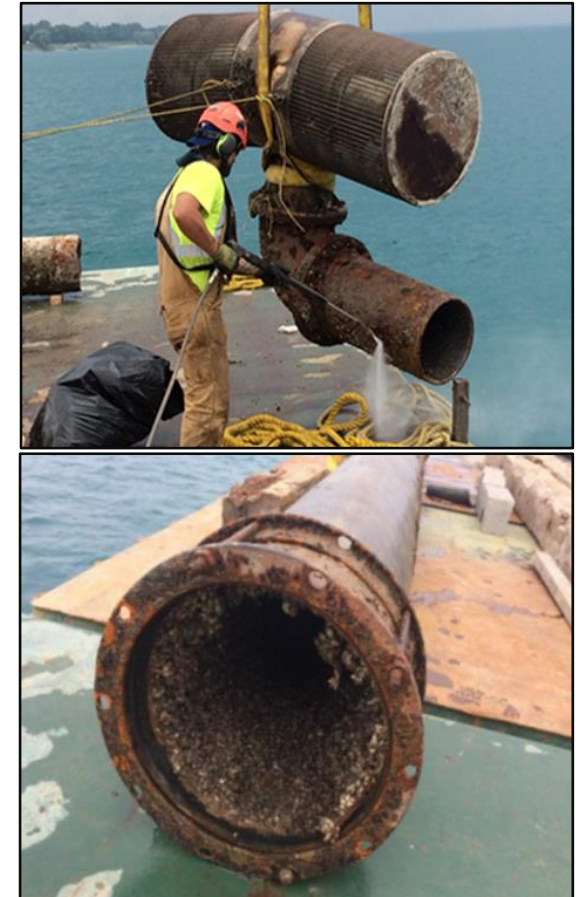
- Existing intake pipe:
 - Installed in 1944 to replace the original intake pipeline constructed in 1896.
 - Extends approximately 400m into Lake Huron.
 - 400mm diameter cast iron pipe.
 - Equipped with an intake screen to allow water flow into the pipe and crib structure to protect the screen.
 - Recently retrofitted with zebra mussel and frazil ice control systems.
- **Intake pipe is at the end of its useful life.** Its current condition results in hydraulic capacity limitations, maintenance concerns resulting in risk of failure.
- Expected capital costs are \$16.2Million.

Photos taken of intake screen, pipe cut-out section, zebra mussel infestation, pipeline crack near the shoreline.

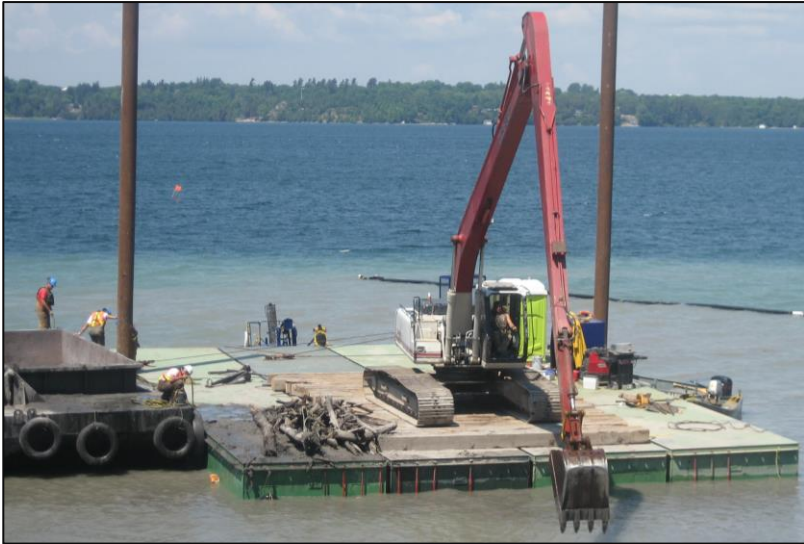
Excavation of marine trench with floating dredging equipment

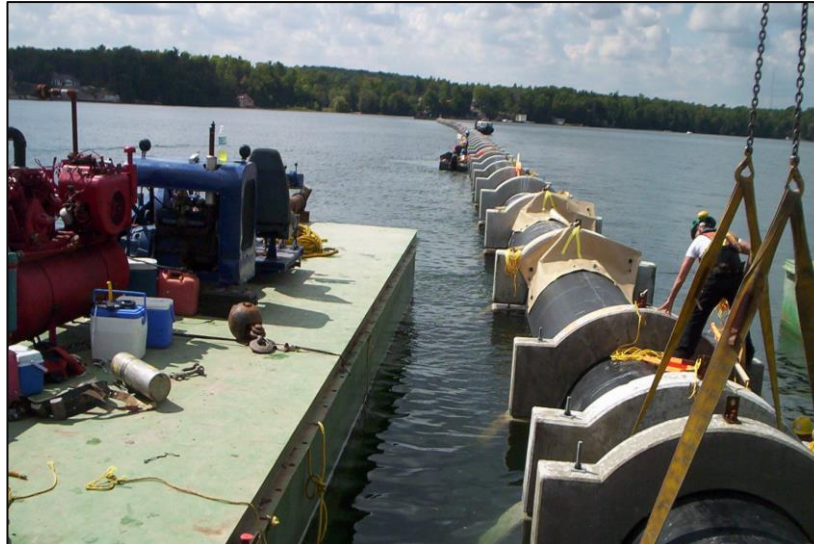
Installation of intake pipeline with ballast to prevent pipeline from floating

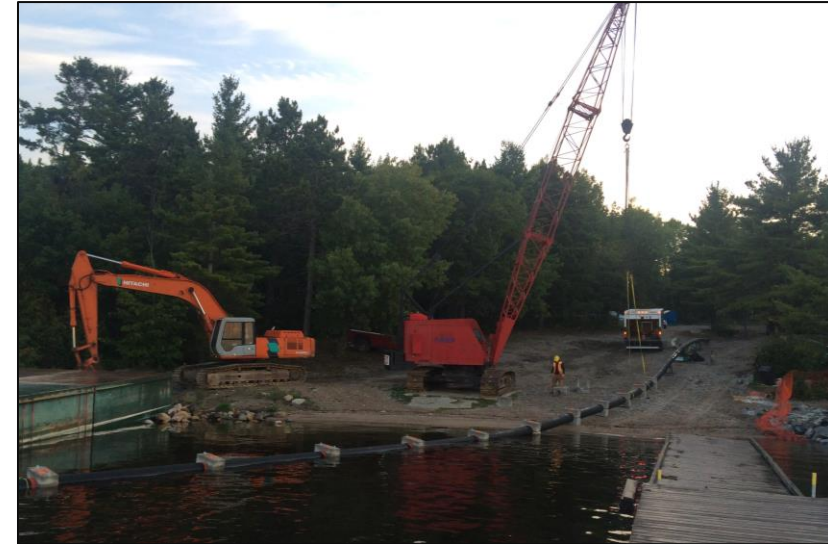
Onshore installation of intake pipeline

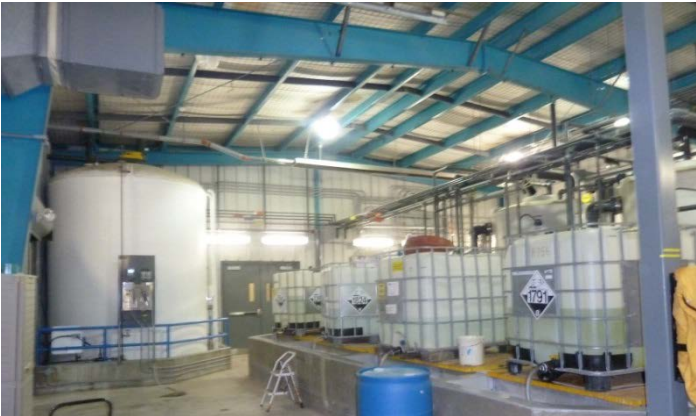
3	
monorail	Steel mono rail	<ul style="list-style-type: none"> Minor rust on bracing (tie rods) Support beams seated on block wall, block not tight to beam on sides.

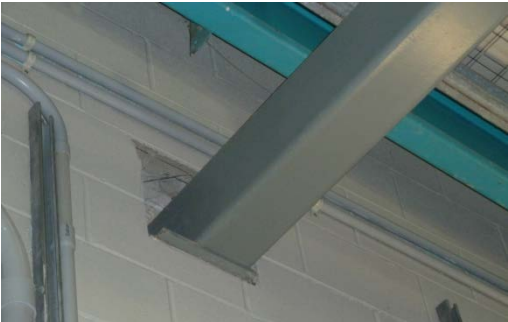
3	
Chemical Containment	Concrete Coated Concrete FRP Grating Support	<ul style="list-style-type: none"> Paint cracked at expansion joint. Operator informed us that it is already to be fixed under maintenance contract 	3 4

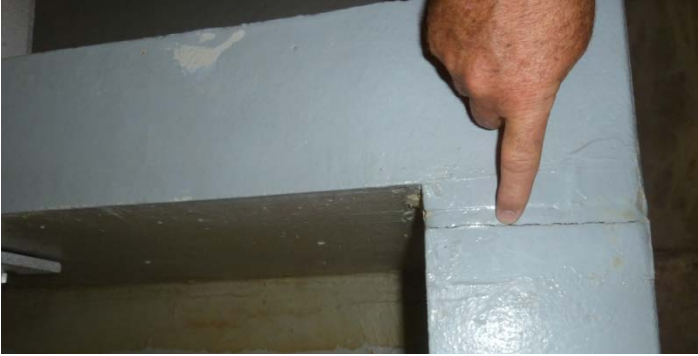
<ul style="list-style-type: none"> Containment coatings have failed in places

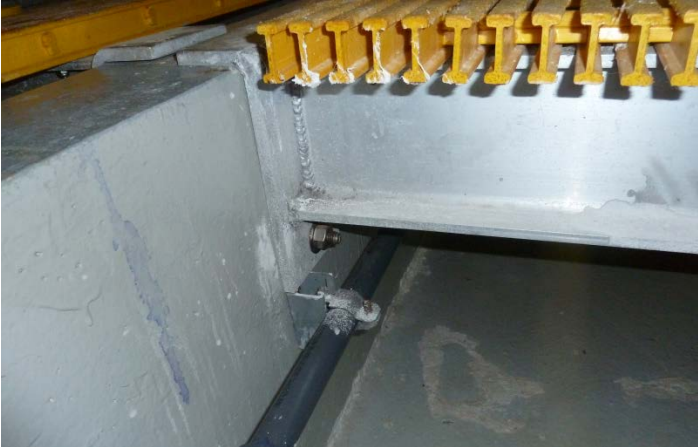
MAJOR EQUIPMENT				
Element	Description	Observations/Recommendations	Condition Grading	Picture ID
Neutralization Tank Containment	Coated Concrete Tank below with open grate	<ul style="list-style-type: none"> Containment area not large enough but containment is provided by second tank below the floor, tank was not entered.

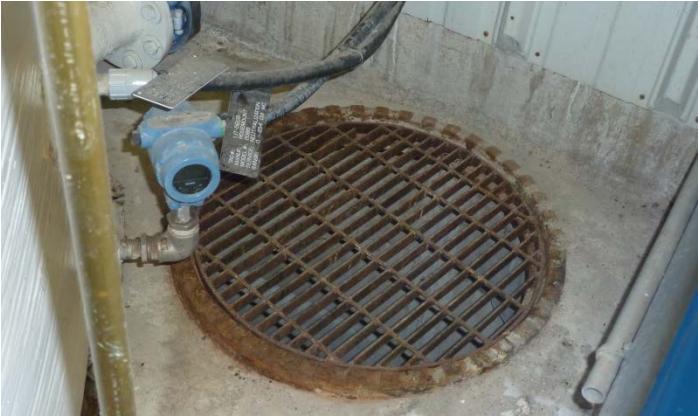
<ul style="list-style-type: none"> Coatings in containment failed Concrete in tank has chemical attack due to leak according to the operators 	4	
Window Well	Interior wall	<ul style="list-style-type: none"> Fills with water periodically due to roof leak 	4	
Flashing	Exterior metal flashing	<ul style="list-style-type: none"> Flashing at northeast corner is coming loose at top due to spalled brick 	3

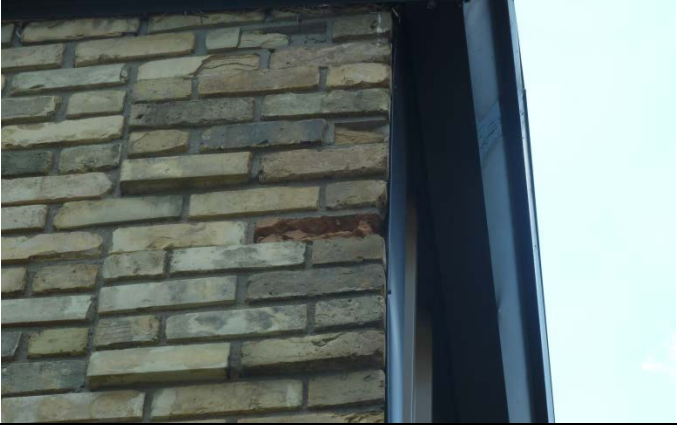
MAJOR EQUIPMENT				
Element	Description	Observations/Recommendations	Condition Grading	Picture ID
brick	North wall is Original brick facade	<ul style="list-style-type: none"> The brick on the upper east and west corners of the façade are spalling.

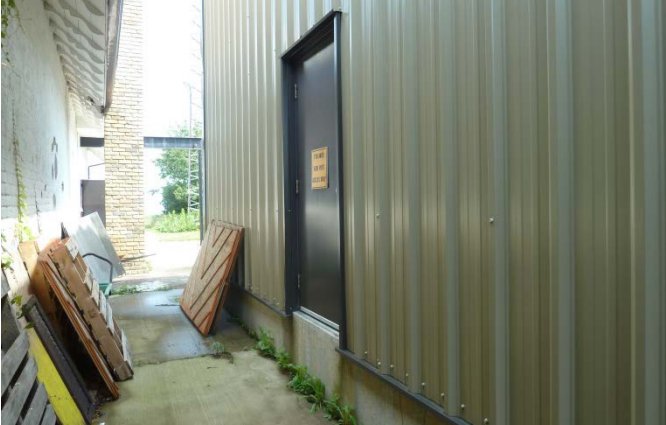
Man-doors	Two man-doors, at Chemical Building on west elevation	<ul style="list-style-type: none"> Both doors are 0.5m off the ground and have no stair access; there is no room for stair access.

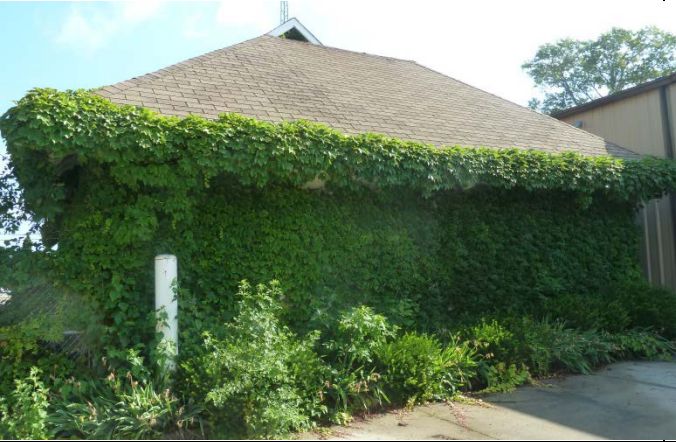
MAJOR EQUIPMENT				
Element	Description	Observations/Recommendations	Condition Grading	Picture ID
Roof	Asphalt shingle hip roof with wood rafters	<ul style="list-style-type: none"> Near end of life Ivy at eaves blocking drainage

4	
Exterior Cladding	Stucco brick with ivy	<ul style="list-style-type: none"> Stucco is spalling behind ivy 	4

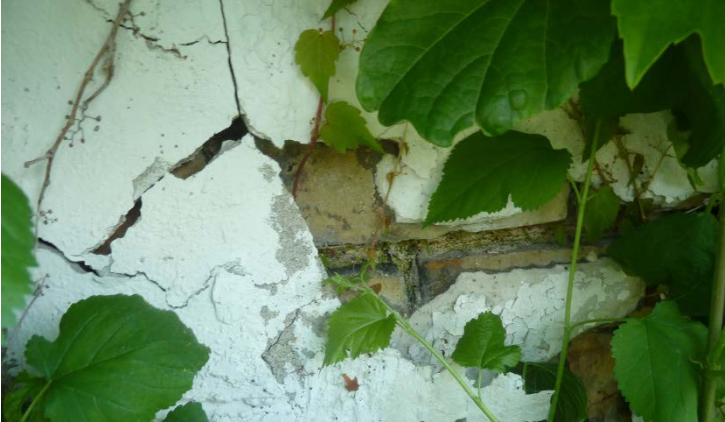
<ul style="list-style-type: none"> • Previous repairs made and are cracking

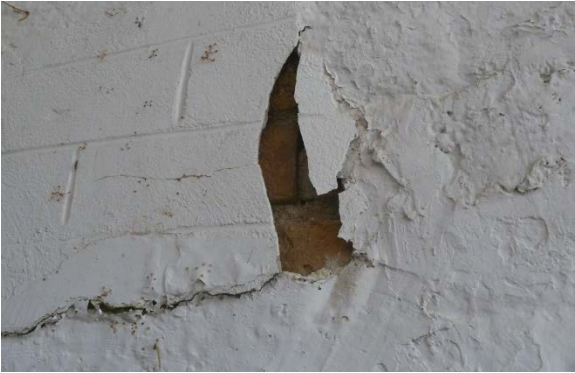
<ul style="list-style-type: none"> • 10% of stucco is failing • Original stucco to cover brick; brick issues are not visible • 1mm wide cracks diagonal at windows on north elevation

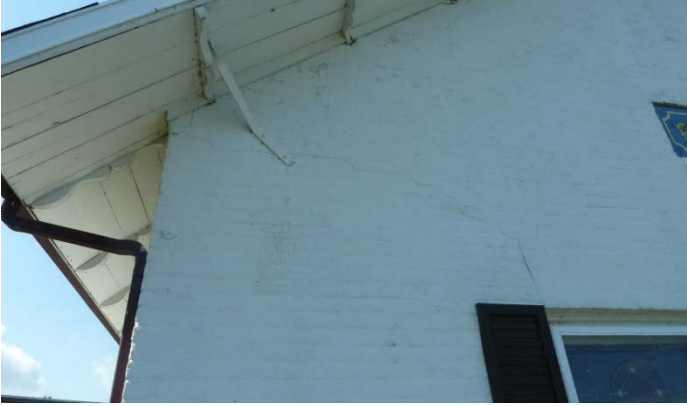
<p>Structural cracks at roof line on north face</p>

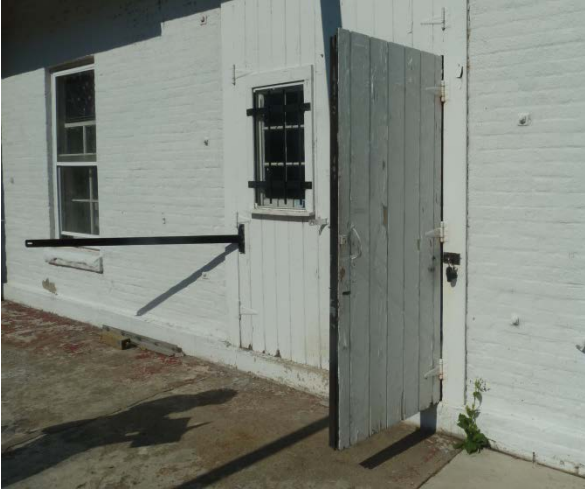
MAJOR EQUIPMENT				
Element	Description	Observations/Recommendations	Condition Grading	Picture ID
Door	Steel double door with wood panelling	<ul style="list-style-type: none"> Hinges and lock are in reasonable condition Wood veneer needs refurbishment and paint

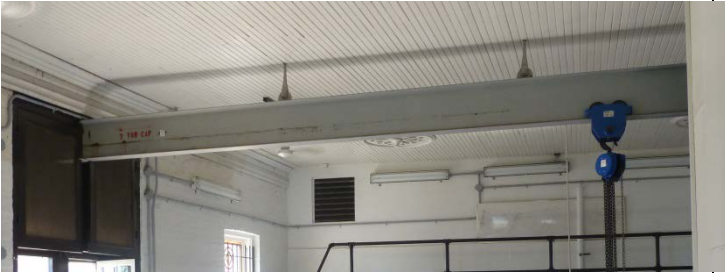
<ul style="list-style-type: none"> Security bars on window in door 	3	
Monorail	3 Ton capacity	<ul style="list-style-type: none"> Some rust visible; paint required Supports not visible

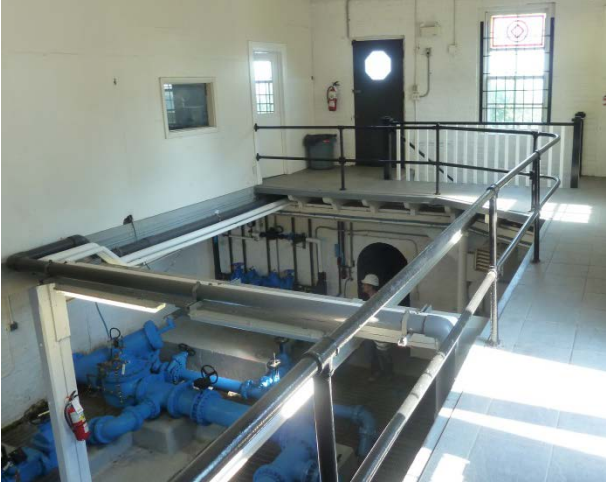
MAJOR EQUIPMENT				
Element	Description	Observations/Recommendations	Condition Grading	Picture ID
Handrail	Painted steel	<ul style="list-style-type: none"> Height of handrail is approximately 90cm which is too low and not to code

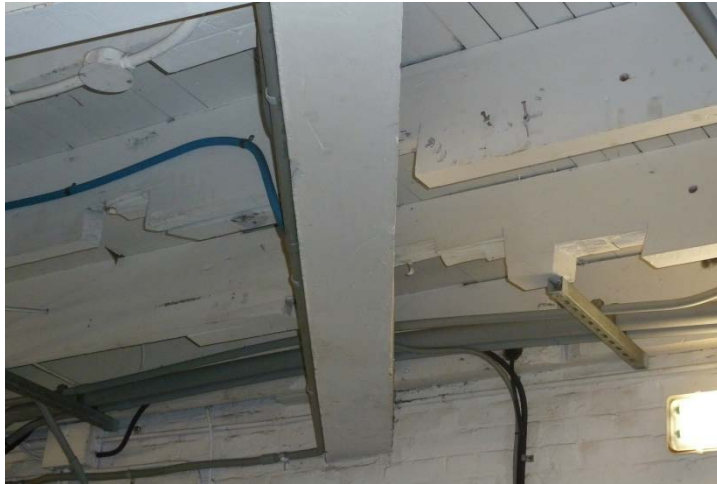
MAJOR EQUIPMENT				
Element	Description	Observations/Recommendations	Condition Grading	Picture ID
Office	Wood construction	<ul style="list-style-type: none"> • Wood needs paint • Supporting wood trusses have many sections cut out; but distress in the remaining wood was not noted. Any further revisions to this wood construction will require design by a structural engineer.

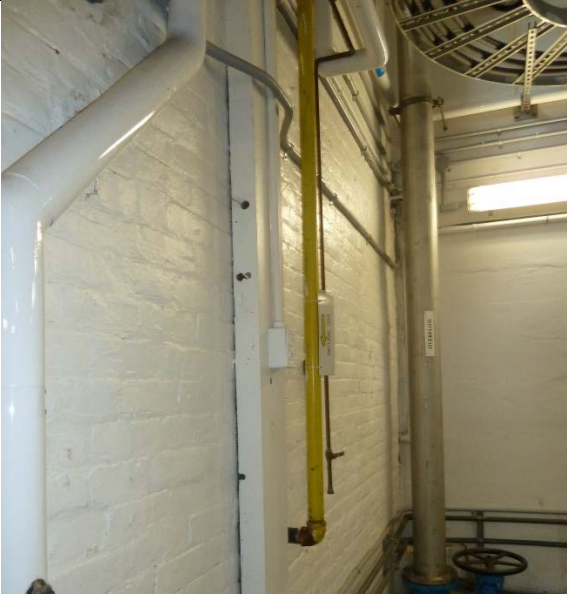
<ul style="list-style-type: none"> • • Groundwater leaking in pipe chase wall • West wall – major crack and general moisture problem on brick wall • Flowing water at base of west wall

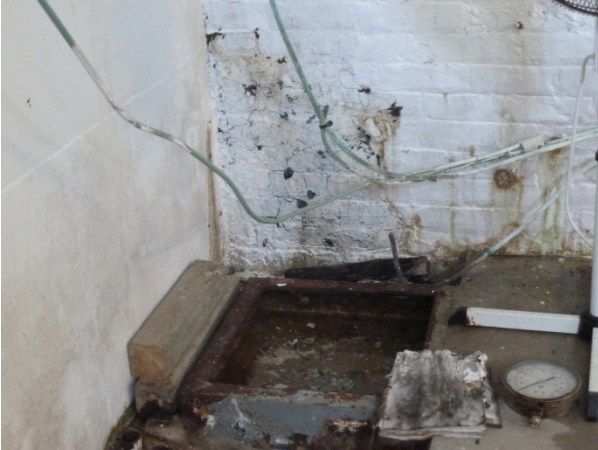
<ul style="list-style-type: none"> • Standing water in southwest corner at abandoned steel support. Remove to allow water to drain.

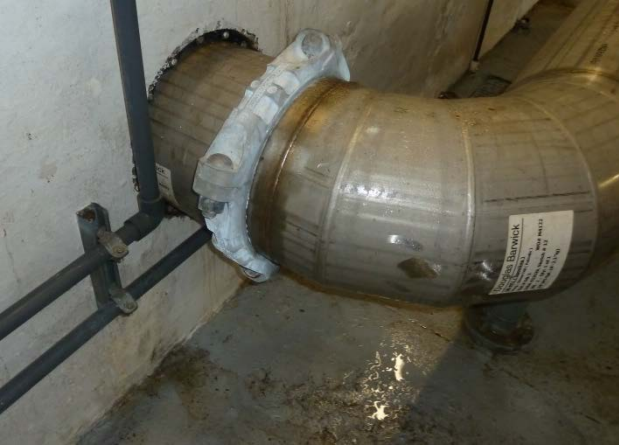
<ul style="list-style-type: none"> • Pipe leaking on south wall. No rust evident. One or two link seals are being used.

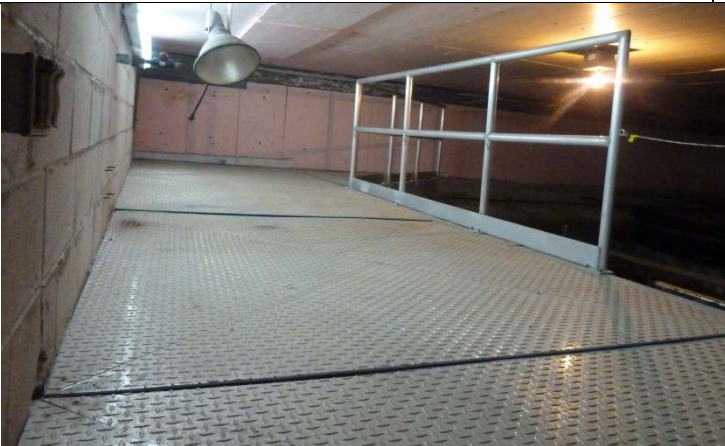
MAJOR EQUIPMENT				
Element	Description	Observations/Recommendations	Condition Grading	Picture ID
	covers, walls and ceiling are insulated. Tank has PVC curtains baffles.

<ul style="list-style-type: none"> • Ceiling covered in insulation; not visible • Top 300mm of PVC curtain baffles visible • New concrete block on north wall in good condition • Other walls are insulated and not visible • Tension rods visible over tank and cast into concrete lip at top of baffles. Some rust on rods to be cleaned and inspected. 	3

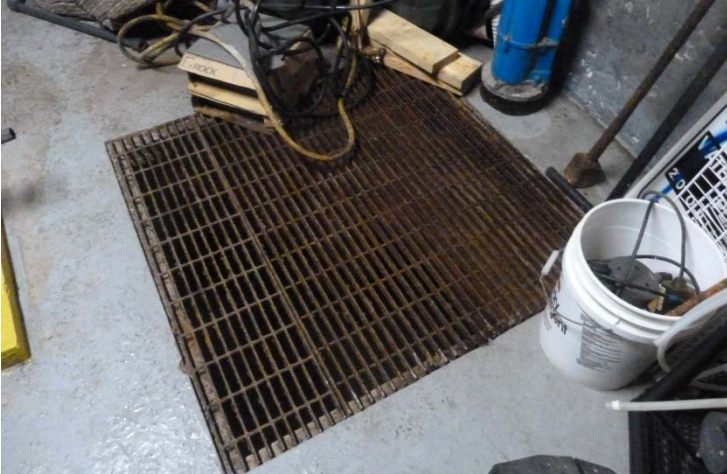
MAJOR EQUIPMENT				
Element	Description	Observations/Recommendations	Condition Grading	Picture ID
Room)	place concrete tank, and concrete slab above water level used for equipment storage.	<ul style="list-style-type: none"> Painted metal grating is rusting

<ul style="list-style-type: none"> Handrail over pit is not correct height according to code 2' of water in the well Well is circular, cast-in-place with previous repairs Temporary ladder is not tied off Superstructure is painted brick

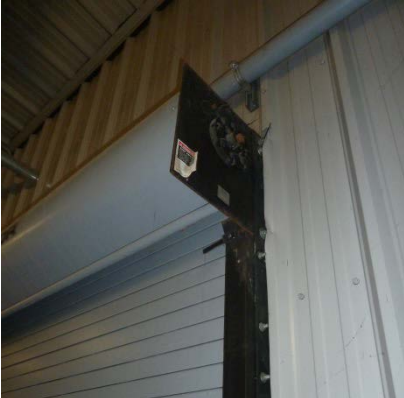
MAJOR EQUIPMENT				
Element	Description	Observations/Recommendations	Condition Grading	Picture ID
Rollup Doors	Roll-up doors, East Elevation	<ul style="list-style-type: none"> Minor rust on frame and hardware

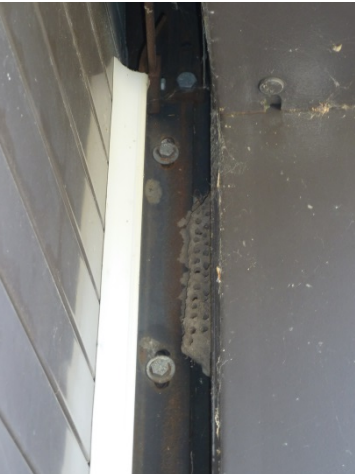
3	
Rollup Door	Roll-up door, West Elevation	<ul style="list-style-type: none"> Exterior door on the west side, has wasp nest between door frame and cladding.

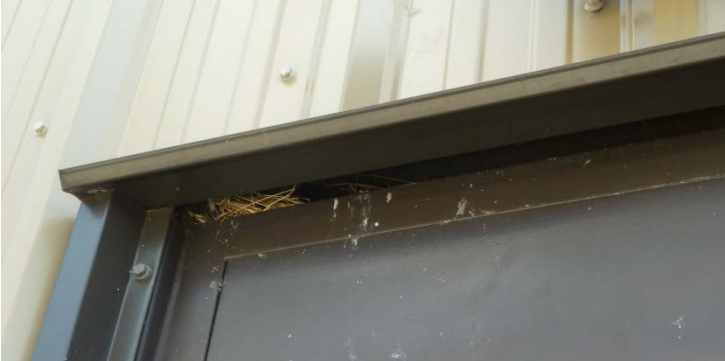
MAJOR EQUIPMENT				
Element	Description	Observations/Recommendations	Condition Grading	Picture ID
Equipment Pads and Pipe Supports	Concrete Pads Steel Post Supports Steel Frame Painted Steel Frame Galvanized	<ul style="list-style-type: none"> • Good 	2	
Exterior Mandoor	West elevation	<ul style="list-style-type: none"> • Nests above door frame between frame and underside of cladding

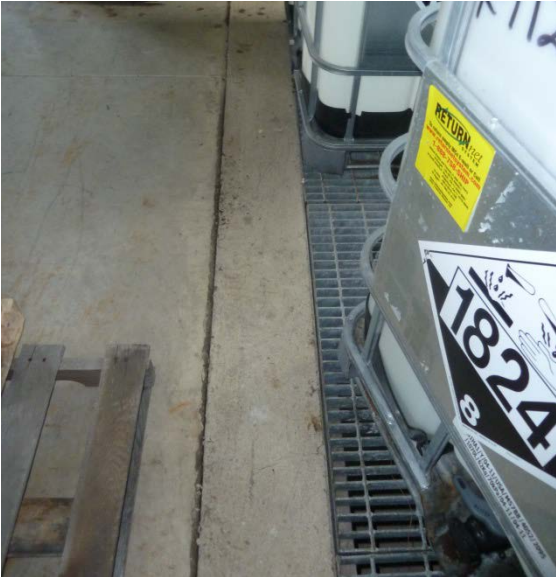
MAJOR EQUIPMENT				
Element	Description	Observations/Recommendations	Condition Grading	Picture ID
Floor	Uncoated cast-in-place concrete	<ul style="list-style-type: none"> Expansion joints open

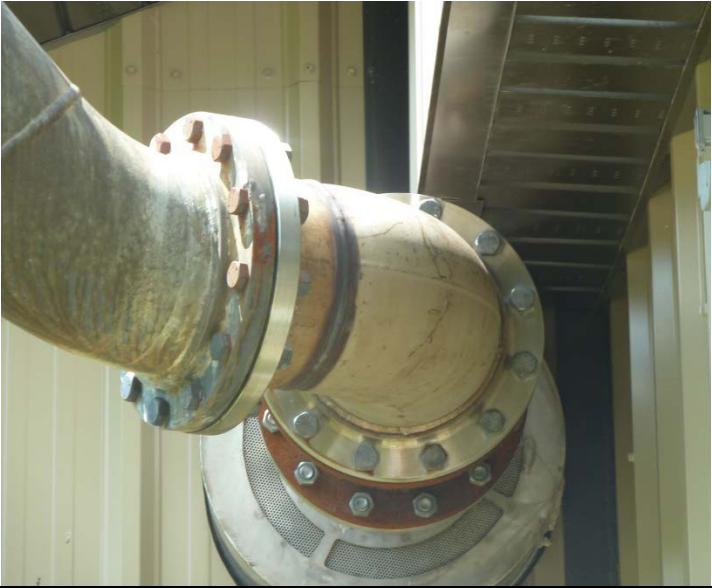
MAJOR EQUIPMENT				
Element	Description	Observations/Recommendations	Condition Grading	Picture ID
Exhaust Stack	Diesel Exhaust Stack bolted to concrete base	<ul style="list-style-type: none"> • Very little clearance to soffit for exhaust piping. • A pipe is running under the soffit – is the soffit non-combustible?

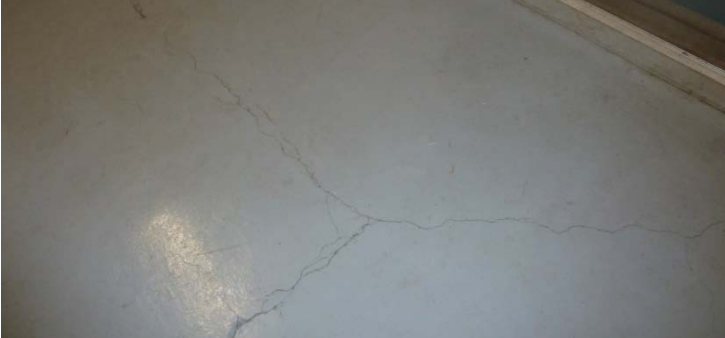
MAJOR EQUIPMENT				
Element	Description	Observations/Recommendations	Condition Grading	Picture ID
Floor	Painted concrete	<ul style="list-style-type: none"> Minor cracking

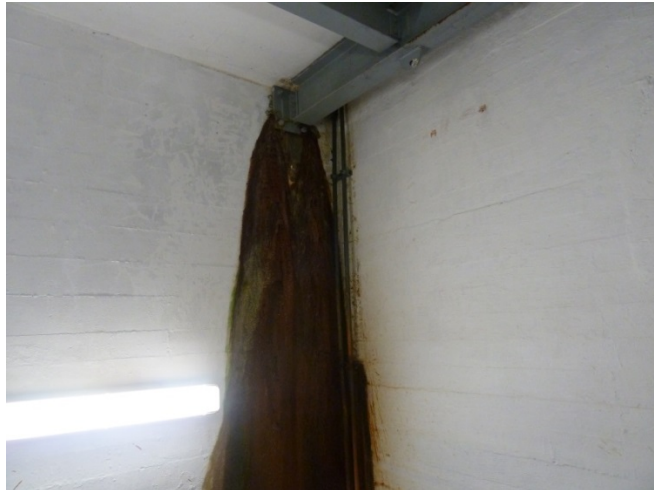
MAJOR EQUIPMENT				
Element	Description	Observations/Recommendations	Condition Grading	Picture ID
Low Lift Pump room	Pump room in second level below grade. Access by ships ladder.	<ul style="list-style-type: none"> Leak in south wall at floor support beam. Leak has been ongoing since 2005 based on discussions with operations. Rust and minerals have built up on wall, and there is concern over the reliability of the anchors supporting the floor beam.

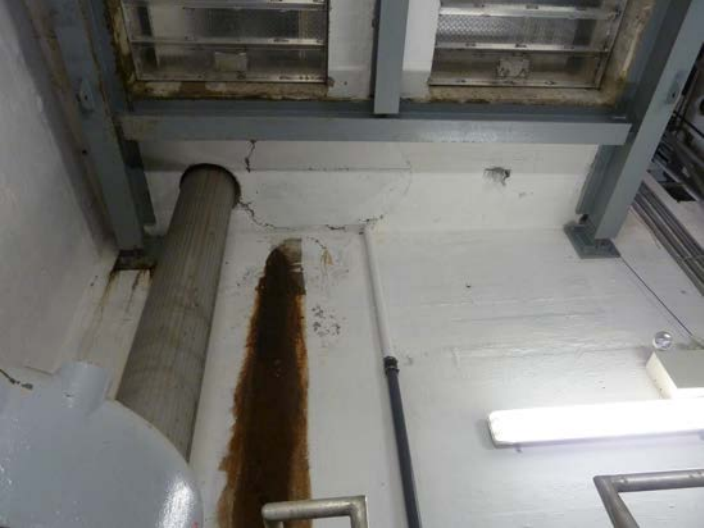
MAJOR EQUIPMENT				
Element	Description	Observations/Recommendations	Condition Grading	Picture ID
		<p>Leak in north wall at beam support location and a floor sump location.</p>

Basement Walls	Cast-in-place concrete	<ul style="list-style-type: none">• Minor leaks• Leaks on west wall at pipe penetration	3

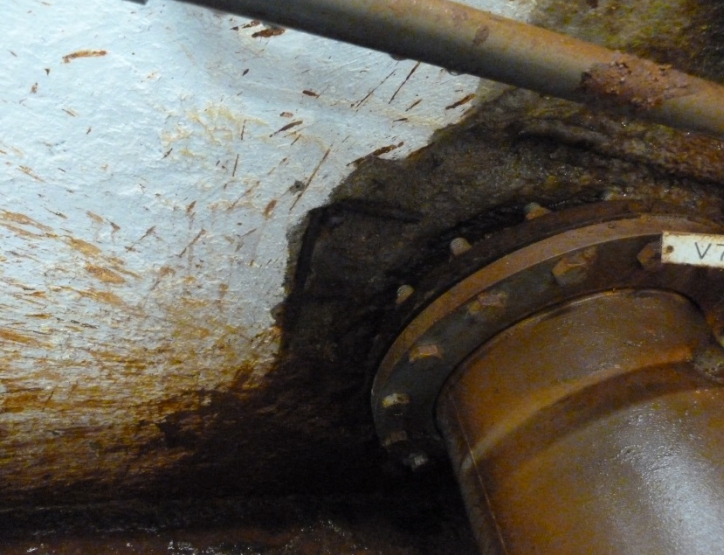
Raw Meter Room		<ul style="list-style-type: none">• Manhole cover in existing roof slab; exposed rebar and spalling concrete

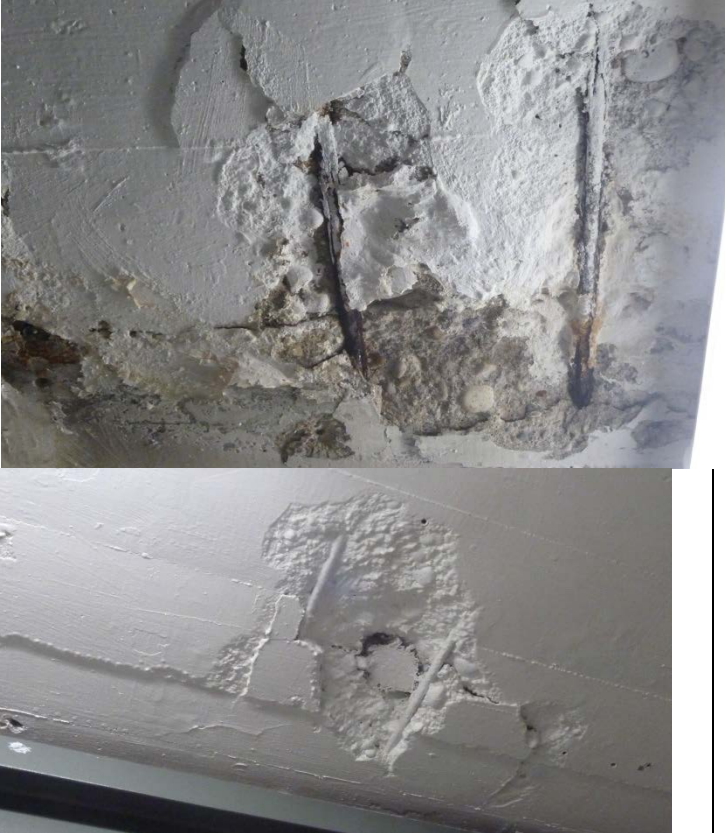
MAJOR EQUIPMENT				
Element	Description	Observations/Recommendations	Condition Grading	Picture ID
		<ul style="list-style-type: none"> Cast-in-place concrete ceiling has spalling on main beam and in 20 locations on ceiling

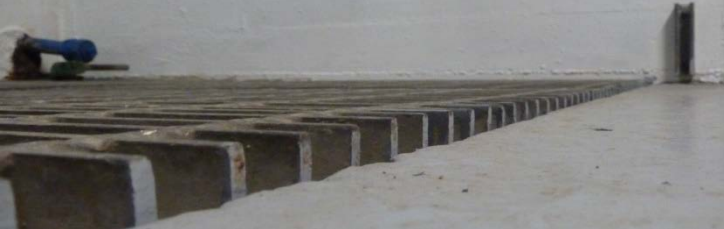
<ul style="list-style-type: none">• Old wood door frame, door not used• Steel support for grating at stair is rusting; 5% section loss• Stair rebar exposed and rusting below grating

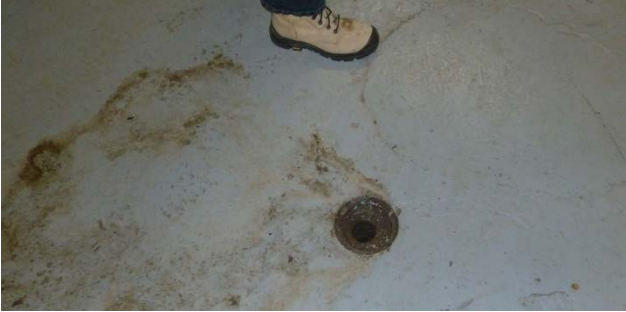
<ul style="list-style-type: none"> • Process drain in floor covered with rusted steel plate (3"x14"). Sump is 8" deep. Sediment 4" deep. Drain pipe clogged; water 6" deep. Alignment of sump lines up with rust in well wall. Basement stain – rebar exposed at bottom below grating.

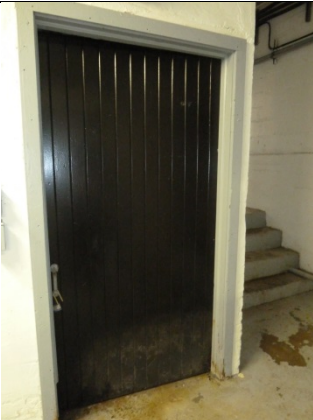
Control Room	Dry wall and tile	<ul style="list-style-type: none"> • Structure is not visible • Closet – holes in floor and drywall • Kitchen – air conditioner has missing trim at top. Tile, counter and sink faucet are OK. • Hall fan has rodent screen but no bug screen. Rodent screen is too small for opening.

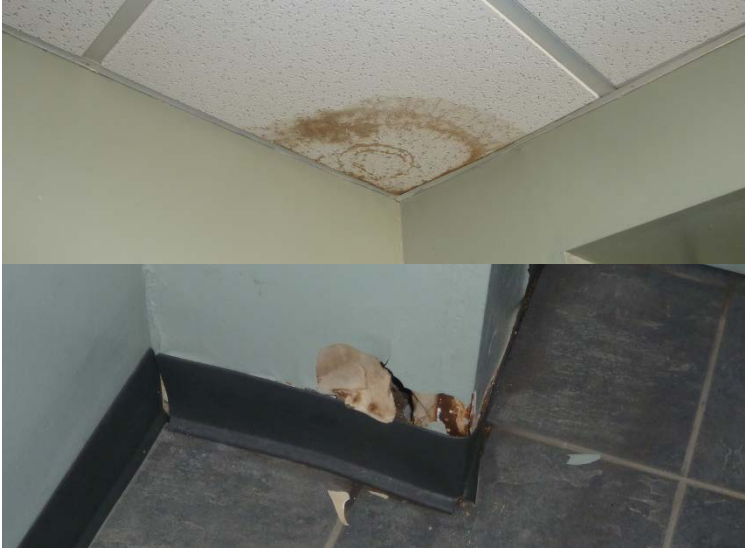
MAJOR EQUIPMENT				
Element	Description	Observations/Recommendations	Condition Grading	Picture ID
	floor	<ul style="list-style-type: none"> Roof leak has caused damage to ceiling and drywall

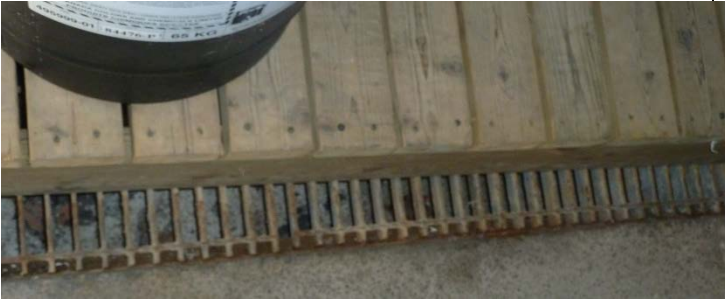
<ul style="list-style-type: none"> • Hydrofluosilicic Acid is being stored on grating 		
Exterior Brick	Yellow brick	<ul style="list-style-type: none"> • Recently fixed 	2	
Stairs to Roof	Concrete	<ul style="list-style-type: none"> • No handrail

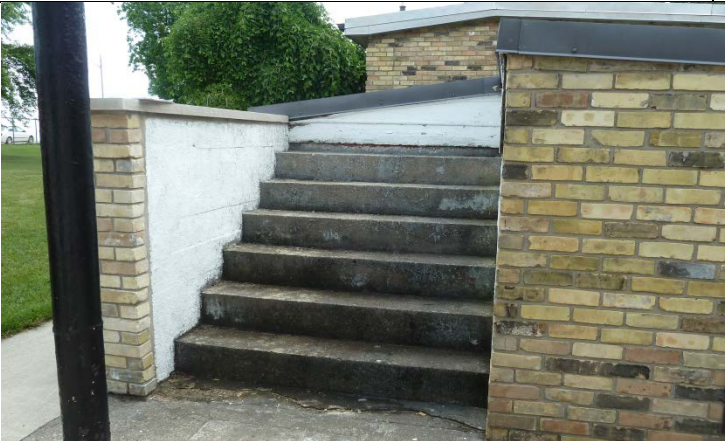
<ul style="list-style-type: none"> Roof area should have handrails all around or have access restricted by barrier.

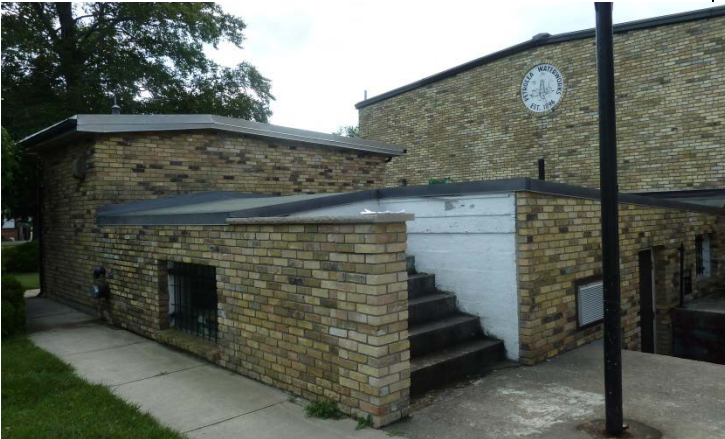
Lower Roof	Built-up tar with metal flashing	<ul style="list-style-type: none"> Water pools in valley; no drain visible 	5 3

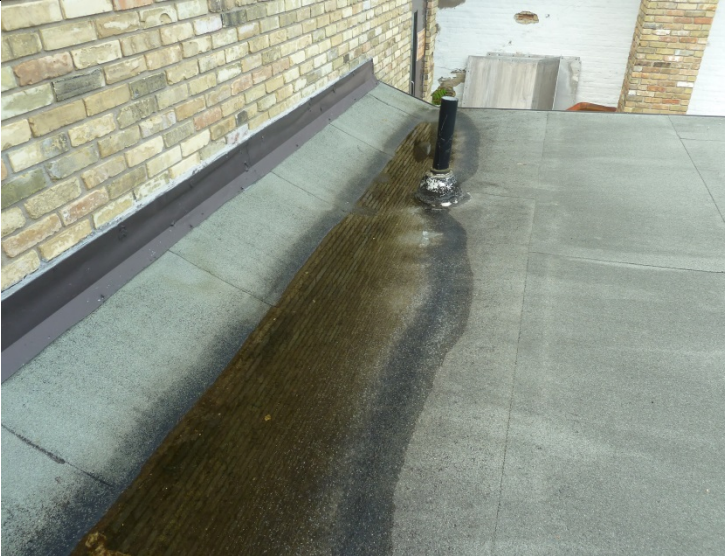
<ul style="list-style-type: none"> Flashing sealant aging

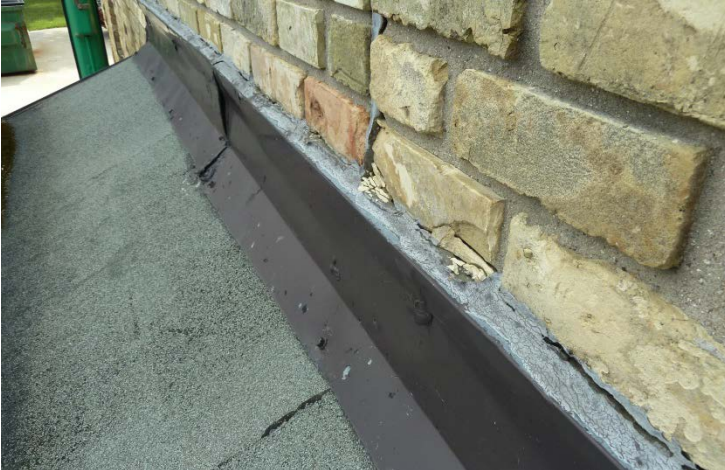
Upper	Tar and gravel	<ul style="list-style-type: none"> Gravel stop holds water on the roof, and does not 	5

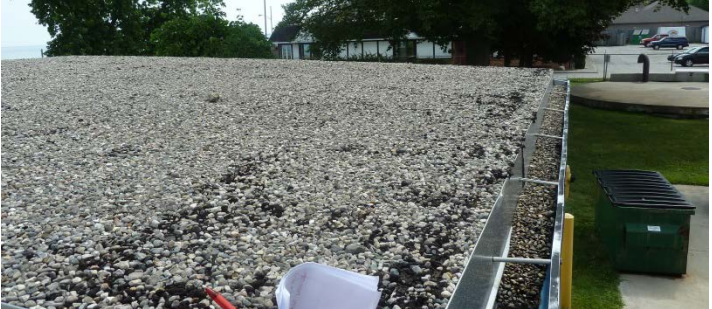
MAJOR EQUIPMENT				
Element	Description	Observations/Recommendations	Condition Grading	Picture ID
Roof		<p>hold back the gravel</p> <ul style="list-style-type: none"> Gutter continuously clogging due to gravel
