Town of Petrolia

Bright's Grove Water Treatment Plant Intake Replacement

Class Environmental Assessment Project File Report

T001646A

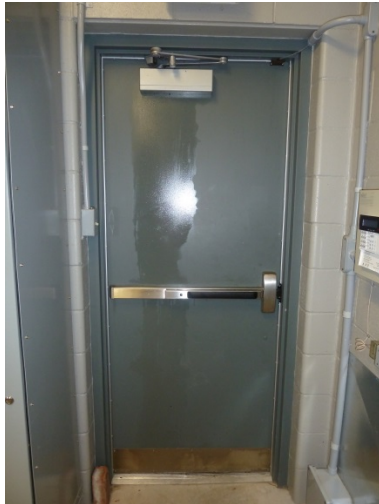
MAJOR EQUIPMENT				
Element	Description	Observations/Recommendations	Condition Grading	Picture ID
Man door	Exterior Steel door with panic hardware and closure	<ul style="list-style-type: none"> Closure is leaking oil

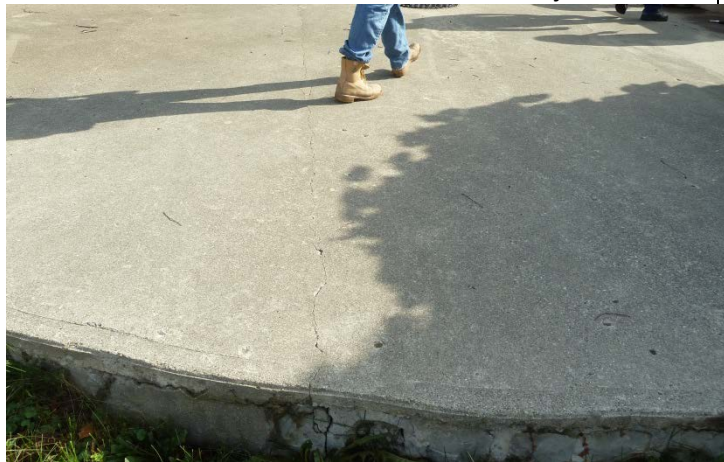
MAJOR EQUIPMENT				
Element	Description	Observations/Recommendations	Condition Grading	Picture ID
Lid	Concrete topping on hollow core slab	<ul style="list-style-type: none"> Concrete cracked on surface at 1m c/c in the North-South direction at location of hollow core joints

<ul style="list-style-type: none"> Hollow core filled at perimeter, parging coming off 	3

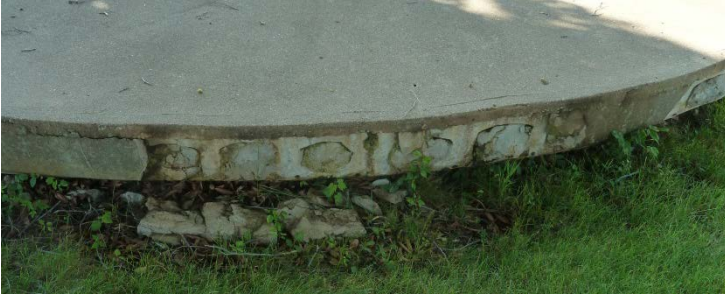
<ul style="list-style-type: none"> • Deteriorating parging on visible exterior • Interior concrete was not visible 		
Hatch	Aluminum with drain channel, lock, stay-open arm	<ul style="list-style-type: none"> • Good condition

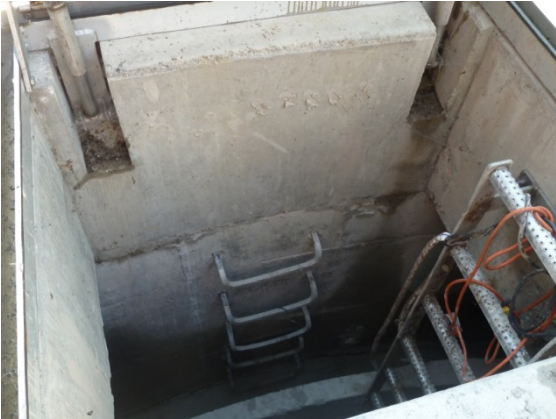
MAJOR EQUIPMENT				
Element	Description	Observations/Recommendations	Condition Grading	Picture ID
Ladder	Aluminum	<ul style="list-style-type: none"> Wire on ladder are a safety concern

<ul style="list-style-type: none"> Tripod required for entry 	2	
Vent Hood	Painted	<ul style="list-style-type: none"> Paint is chipping and has failed needs to be repainted

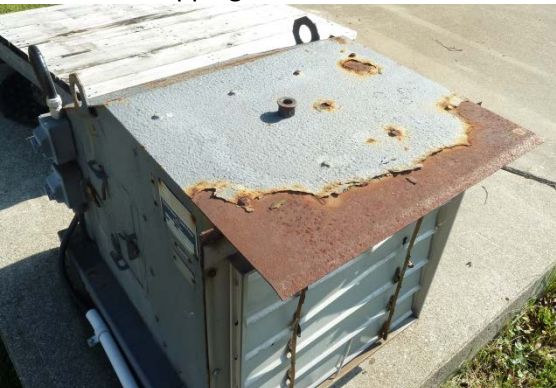
4

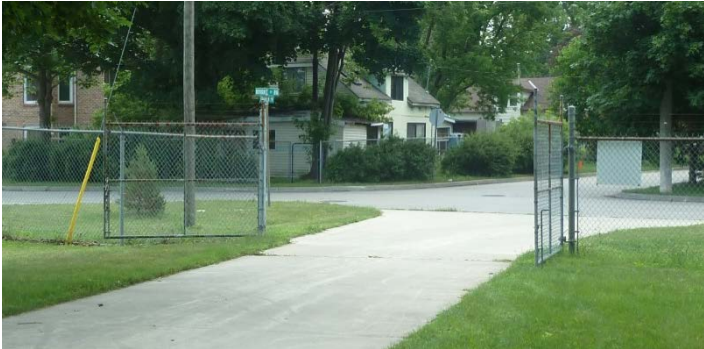
MAJOR EQUIPMENT				
Element	Description	Observations/Recommendations	Condition Grading	Picture ID
Entrance Gate	Located at south side of lot, Galvanized Steel, Pad lock	<ul style="list-style-type: none"> Minor rust on swing gate

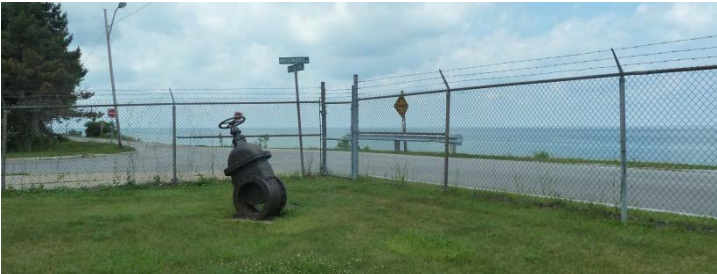
Fence	Surrounds perimeter of lot	<ul style="list-style-type: none"> 6' chain-link fence, with 1' of barbed wire; not high enough to keep people out

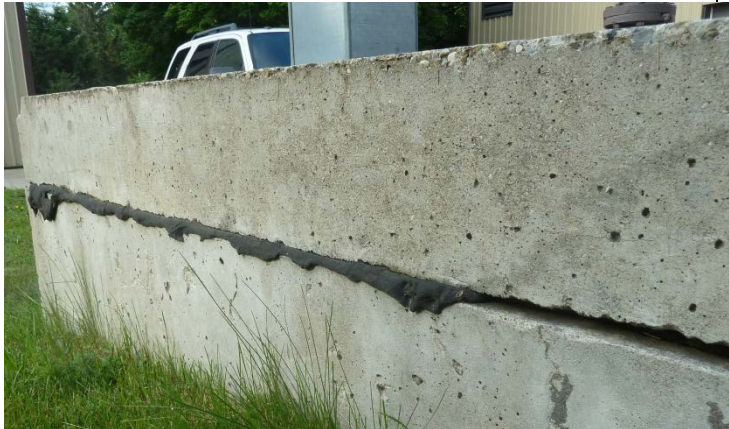
MAJOR EQUIPMENT				
Element	Description	Observations/Recommendations	Condition Grading	Picture ID
Lid	Precast concrete	<ul style="list-style-type: none"> Sealant gasket is worn

<ul style="list-style-type: none"> Corner of tank is chipped (not critical) 	2

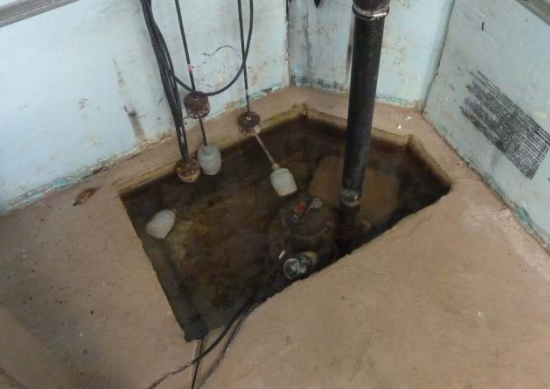
<ul style="list-style-type: none"> • Ceiling not visible due to interior insulation 		
Walls	Precast concrete, insulated	<ul style="list-style-type: none"> • Not visible due to interior insulation 	-	
Floor	Cast-in-place with sump

<ul style="list-style-type: none"> • Sump was full of water, floats for pump not running 	2

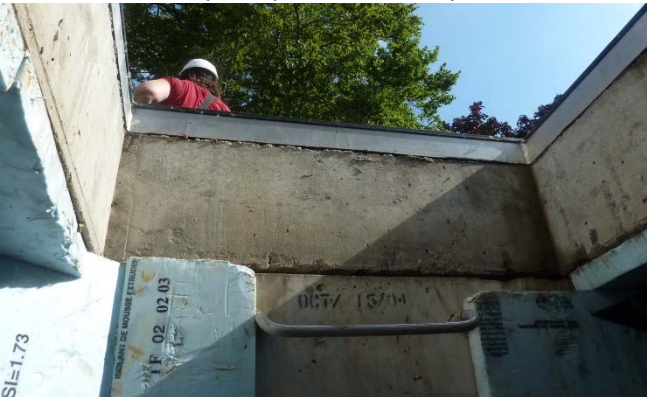
2	
Ladder	Aluminum	<ul style="list-style-type: none"> • Two ladder ups required for safety

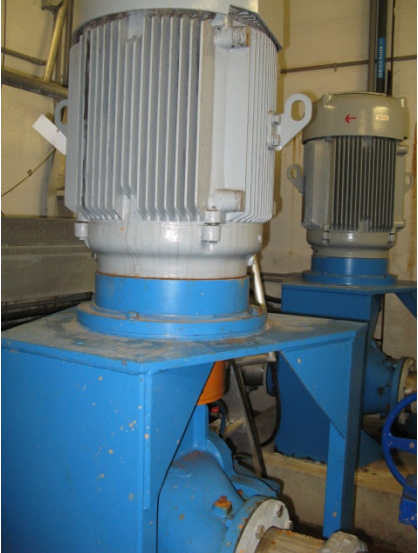
Low Lift Pumps: LLP No.1 LLP No.2 LLP No.3	OMM Section B.20	Capacity =9.75 ML/D Head = 52.5 m Pump Manufacturer= GOULDS Pump Model =3410,6X8-13.4 Motor Manufacturer =BOLDOR Motor Model =18E117X356	Name plates missing. Recommend secure from manufacturer.

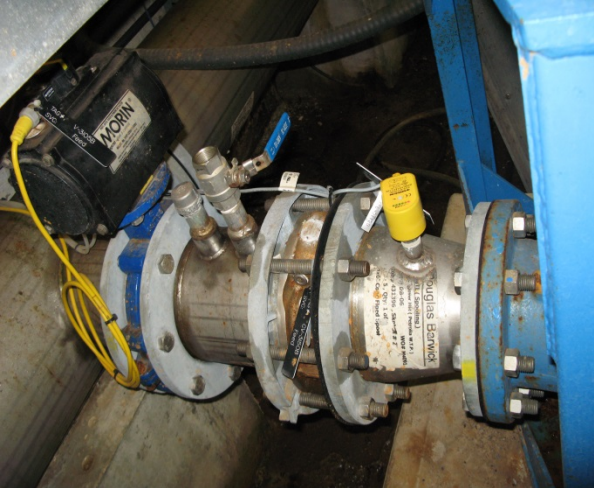
<p>Pneumatic valve control</p>	<p>OMM Section B.20</p>	<p>Pneumatic control on LLP discharge to prevent surge at filter on pump start up.</p>	<p>Pneumatic Control valve not working on all 3 pumps discharge. Recommend system be put back in service.</p>

<p>Vibration issue on Pump #2 to be address by OCWA</p>	<p>5</p>	<p>3324</p>
--------------------------------	-------------------------	--	---	----------	-------------

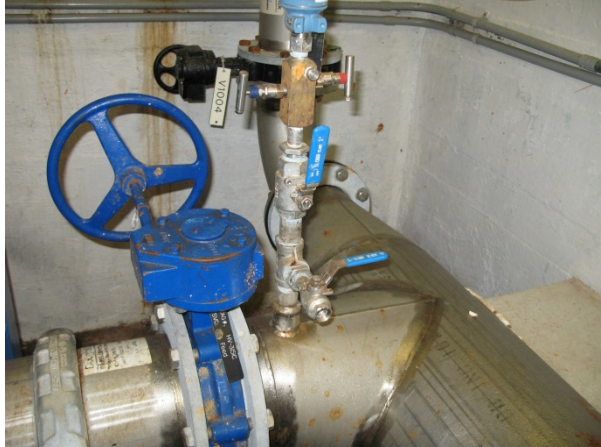
Discharge Piping and Valves		Suction piping and valves	Shows service rust. Paint maintenance required

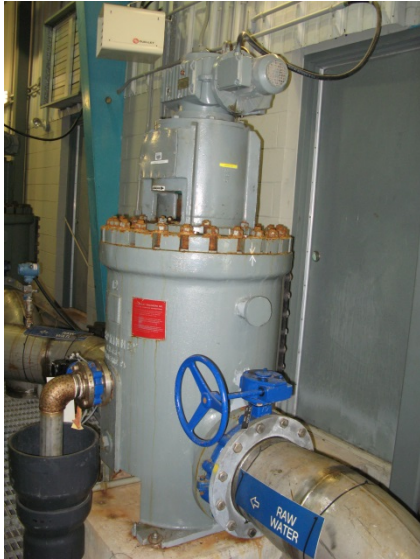
MAJOR EQUIPMENT					
Equipment / Item	Tag Number	Description	Observations/Recommendations	Condition Grading	Picture ID
Automatic Strainers: Strainer No.1 Strainer No.2	OMM section B.30	Capacity = 19.5ML/D Manufacturer = S.P. Kinney Model =A Mesh Size =0.38mm	Screen allowed zebra mussel shells to pass resulting in the shells cutting the membrane

3	3350
			Operation staff installed a Teflon gasket but it failed to prevent passing of the shells.

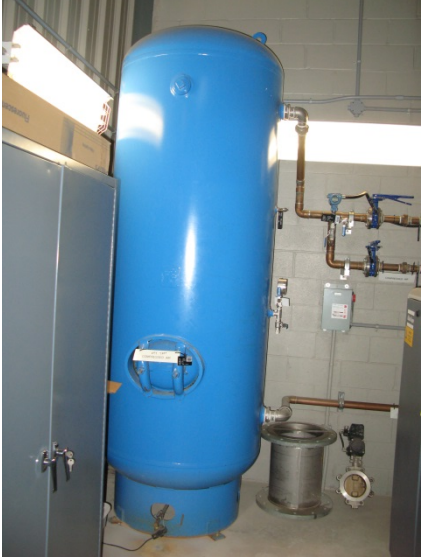
MAJOR EQUIPMENT					
Equipment / Item	Tag Number	Description	Observations/Recommendations	Condition Grading	Picture ID
Pressure tank	OMM Section INFO P-114		Consider recertifying pressure tank

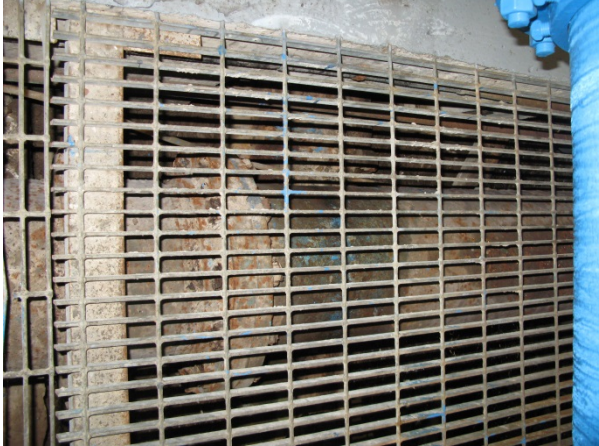
MAJOR EQUIPMENT					
Equipment / Item	Tag Number	Description	Observations/Recommendations	Condition Grading	Picture ID
Discharge Piping and Valves			<p>All piping below the grating appear to be corroded</p> <p>Non-destructive testing is recommended</p>

4	3374

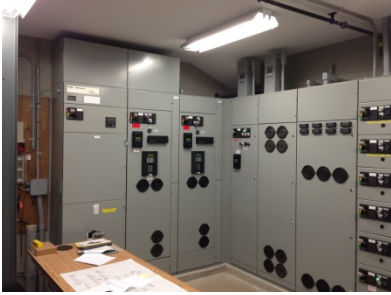
MCC	<p>Main Service Entrance and MCC</p> <p>Eaton, 600V, 3 phase, 1000A horizontal bus</p>	<p>The main service entrance and MCC switchgear are in good condition. The MCC includes multiple motor starters including VFD's that are equipped with ventilation fans. The interior of the respective MCC starter cells should be inspected annually and vacuumed to suit any dust/debris that enters via the ventilation openings.</p>

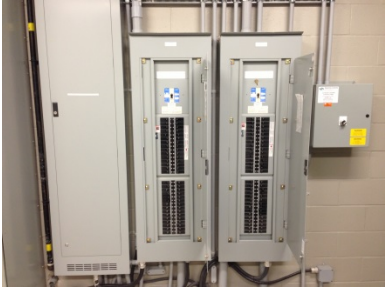
<p style="text-align: center;">2</p>
<p>LPA LPC</p>	<p>Distribution panel boards LPA - 120/208V, 3 phase 60 Circuit LPC - 120/208V, 3 phase 60 Circuit</p>	<p>The lighting panel boards are in good condition. Lighting Panel Board Provides power to automation equipment and instruments. The integrity of the distribution system could be improved with the installation of a surge protection device on the panel.</p>

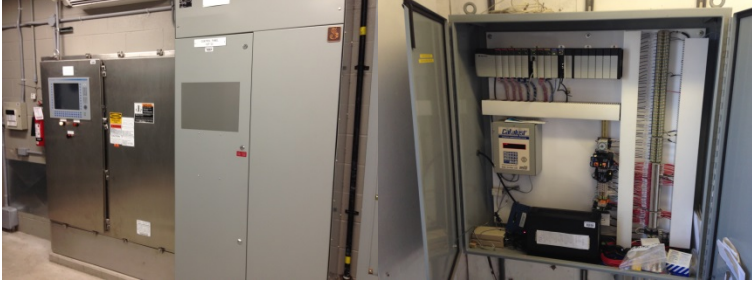
<p>ICP-01, ICP-02 , PAL Main ICP</p>	<p>PLC Control Panels, Microfilter Valve Rack Panels,</p>	<p>The existing PLC control panels are in good condition. ICP-01, and the PAL main control panels are located a temperature controlled room (I.e. the MCC room) ICP-02 is located in the existing High Lift Pumping Station Room. The existing High lift pumping station room is subject to high humidity. The ICP-02 should be equipped with an disposable desiccant absorption product, to reduce the humidity in the panel. The product is inexpensive and typically replaced every 1 to 2 years.</p>

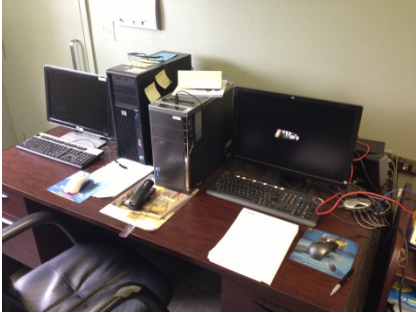
<p>SCADA System HMI</p>	<p>The SCADA system master HMI computer was recently upgraded and is in good condition.</p> <p>The SCADA system includes an older View Node computer located in the Lab area that is equipped with Windows XP and Version 9 Wonderware HMI software (The recently upgraded computer consists of Windows 7 and Wonderware version 10.6) It may be necessary to replace the existing View Node computer hardware (and OS) to improve the integrity of the view node application.</p> <p>The PAL control panel is equipped with an Allen Bradley panel mount PC computer. The PAL SCADA HIM computer is in good condition</p> <p>The LAB room is equipped with a proprietary computer that is dedicated to monitoring and trending of the treatment plant (HACH) analyzers. The manufacturer should be contacted to inspect the system, and to comment on the status.</p>

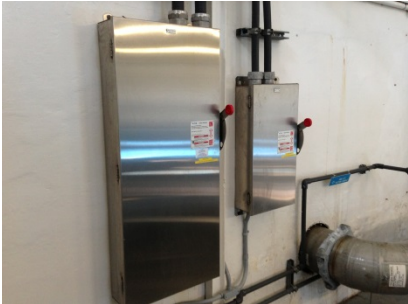
<p>HLPS LLPS</p>	<p>(New Installations) General 120/240VAC Distribution, Disconnects, switches, junction boxes, cable trays</p>	<p>The electrical power distribution consists of a mix of old and new power distribution. New power distribution is installed in rigid PVC conduit raceways and is in good condition. Power conductors include TECK 90 cables in cable trays to service large motor loads that are in good condition. New junction boxes, distribution panels, and disconnect switches are in good condition There are some loose bonding conductors in cable tray that services the pump motor power distribution that should be terminated and confirm ground continuity to building ground.</p>

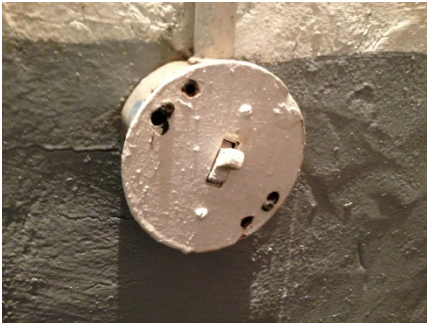
<p>HLPS LLPS</p>	<p>(Old Installations) General 120/240VAC Distribution, switches, junction boxes</p>	<p>The electrical original/old power distribution consists of EMT conduit, and general NEMA 1 type metal junction boxes and receptacles. Original electrical power distribution is in fair to poor condition and it should be replaced during the next capital upgrades at the facility.</p>

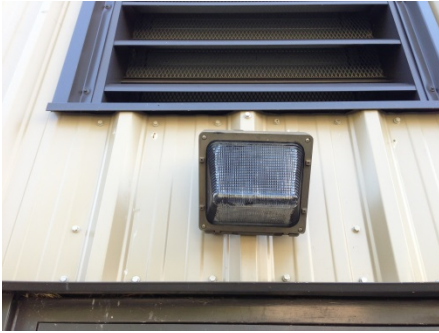
<p>Exterior Lighting</p>	<p>The majority of the exterior lighting consists of high pressure sodium (HPS), 100W, 120V light fixtures.</p> <p>Some of the HPS fixtures glass lenses appear to have dust/debris accumulations. The lenses should be cleaned as required during regular maintenance intervals or lamp servicing.</p> <p>The exterior lighting also includes old incandescent fixtures. The incandescent bulbs should be replaced with energy efficient fluorescent or LED type. Fixtures that have been in service for over 25 – 30 years should be replaced.</p>

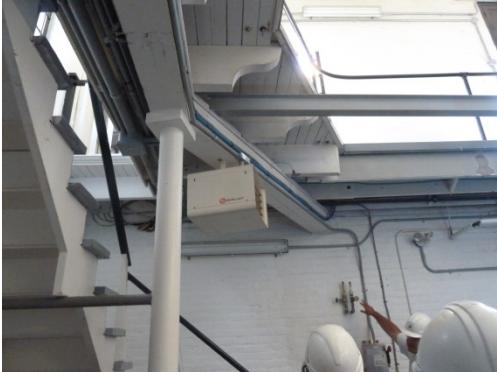
<p>Heating/Cooling and ventilation systems</p> <p>Gen Rm MCC Rm Comp Rm PAL Rm Chem Rm LLP/HLP Rm</p>	<p>Industrial Electric Unit heaters are provided for the heating of the Generator Room, Compressor Room, Low Lift and High Lift Area. The existing unit heaters are in good condition</p> <p>Gas radiant heating units are provided for the PAL process room and the chemical room. The gas fired unit heaters are in good condition.</p> <p>The MCC room and Gas Compressor rooms include cooling units that are in good condition.</p> <p>The Generator room, Compressor room, PAL filter room and Chemical room are equipped with ventilation exhaust fans that are in good condition.</p>

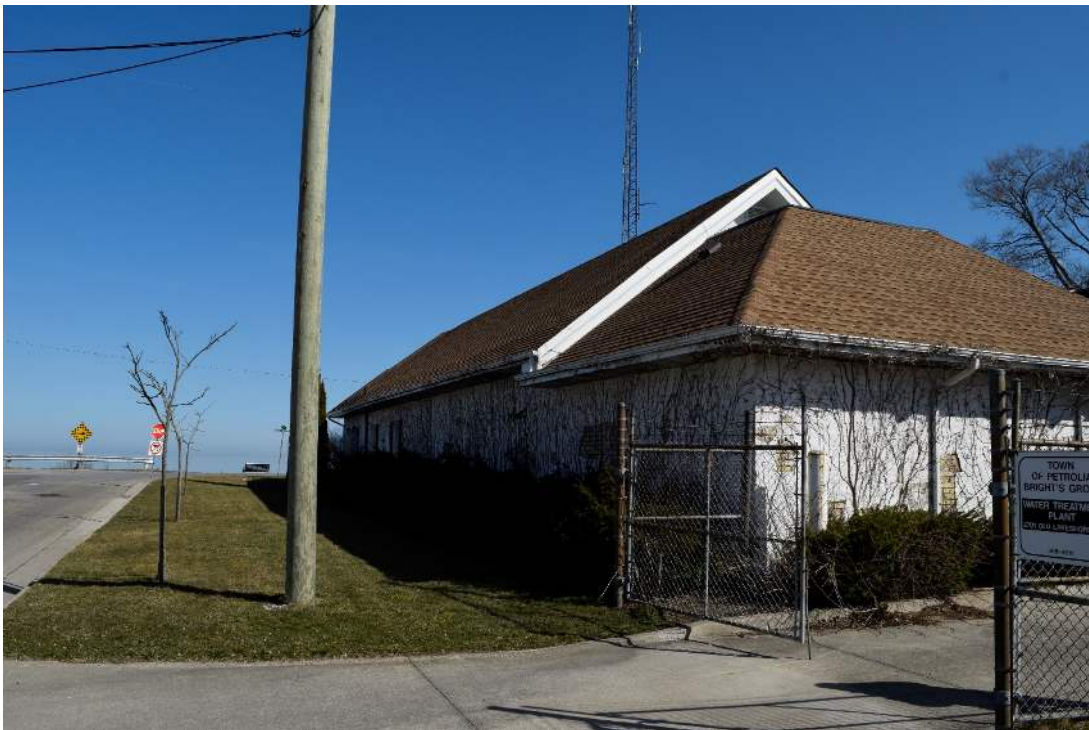
FIGURE 13: SOUTHEAST EXPOSURE, HIGHLIGHTING THE TRANSITION FROM GABLE ROOF LINE TO TRUNCATED HIP ROOF ON SOUTH END OF STRUCTURE

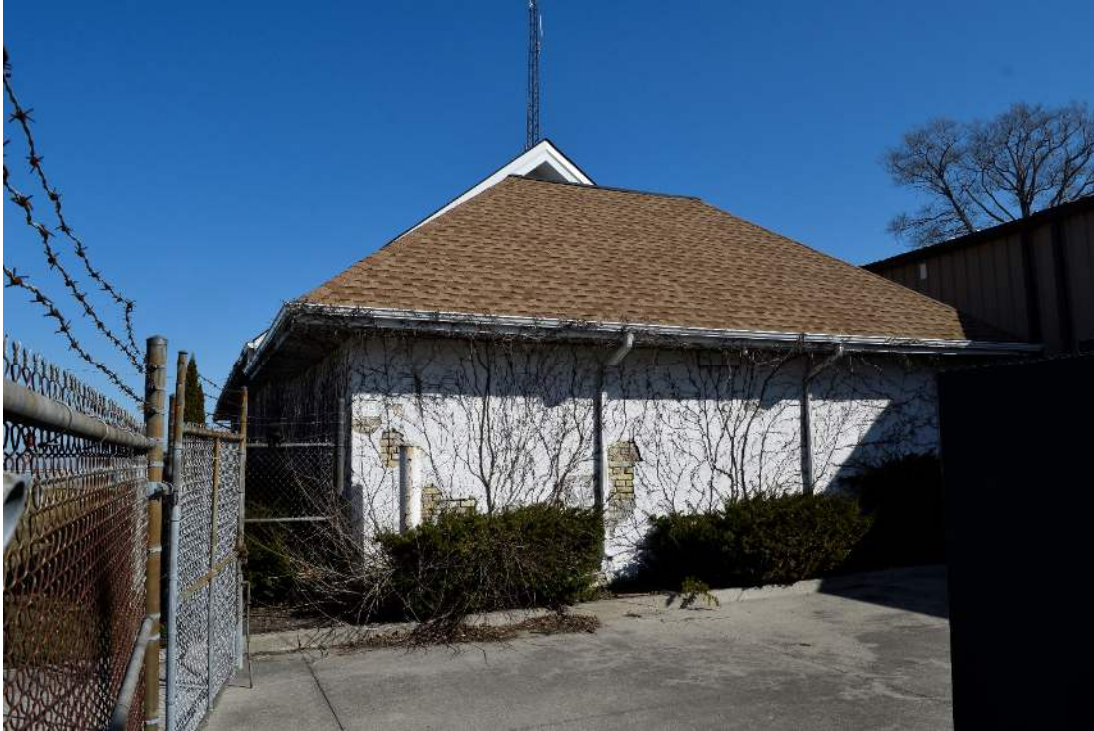
FIGURE 14: SOUTH FACE, FACING NORTH, NOTE THE EXPOSED YELLOW BRICK WHERE WHITE PAINT HAS EXFOLIATED

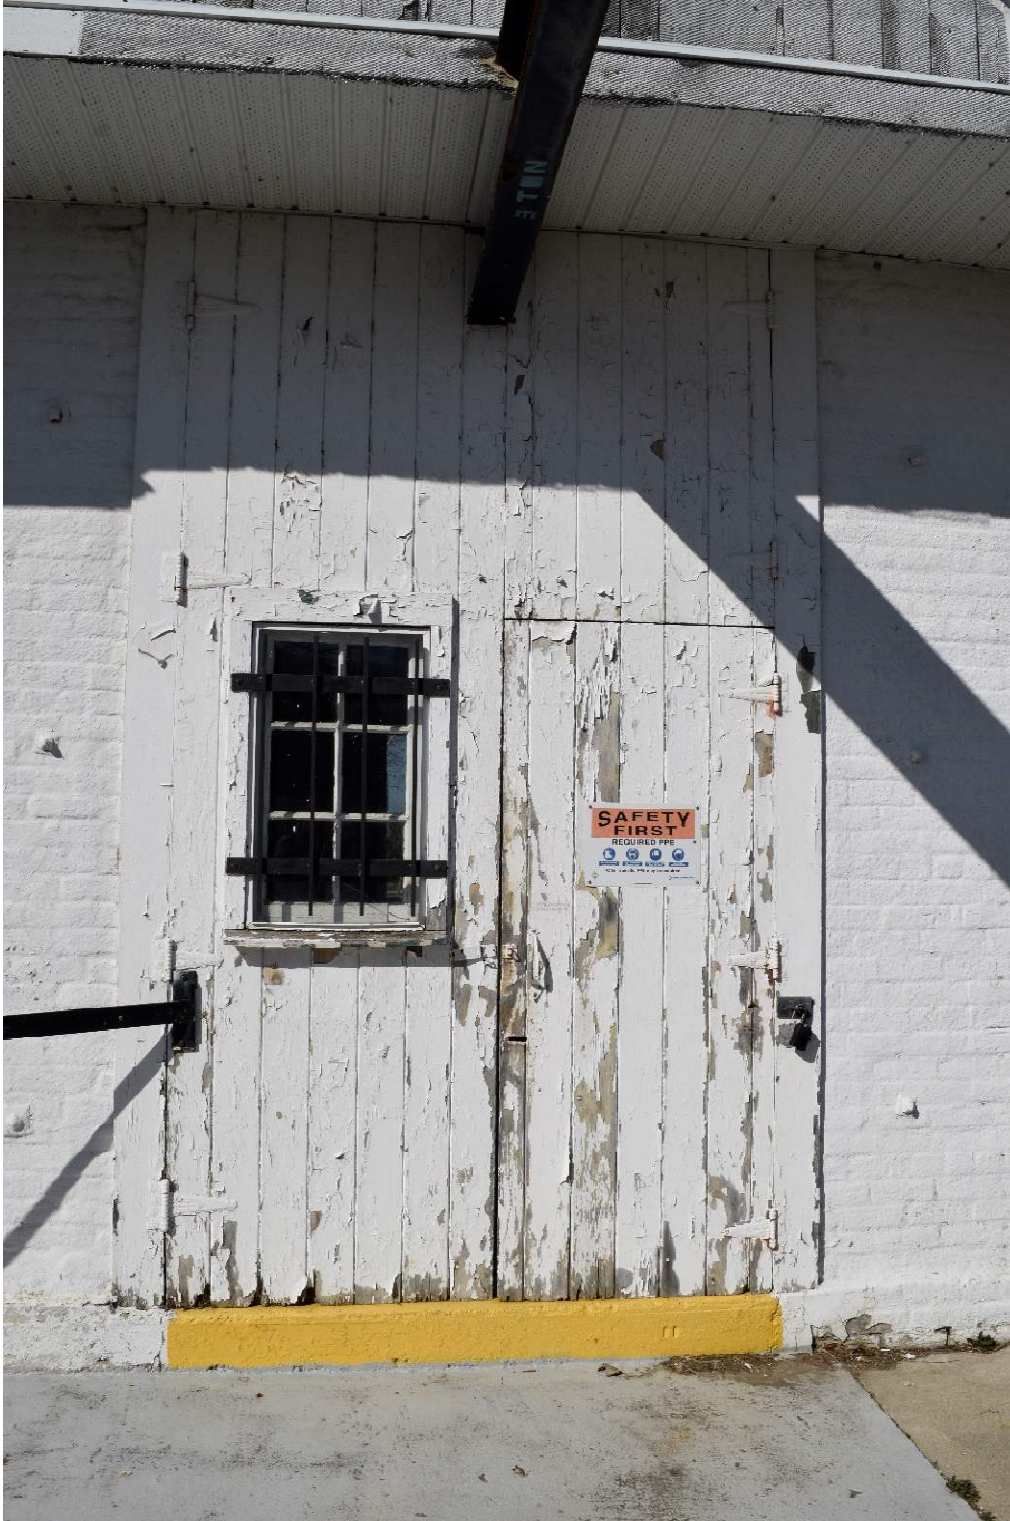
FIGURE 17: HEAVY EQUIPMENT EGRESS WITH INTEGRATED STANDARD EGRESS DOOR, LIKELY ADDED AS PART OF THE 1929 UPGRADES TO FACILITATE THE INCLUSION OF A CHLORINATION SYSTEM

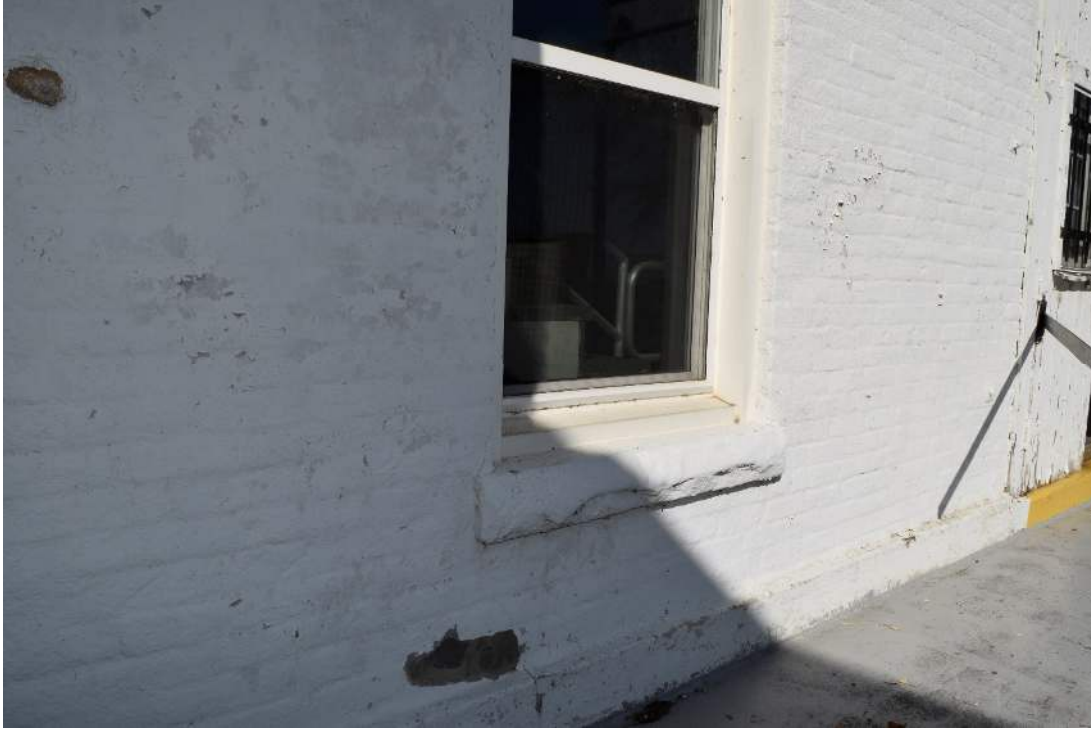
FIGURE 18: EXAMPLE OF TYPICAL CUT STONE LUG SILL, NOTE USE OF MODERN REPLACEMENT WINDOWS

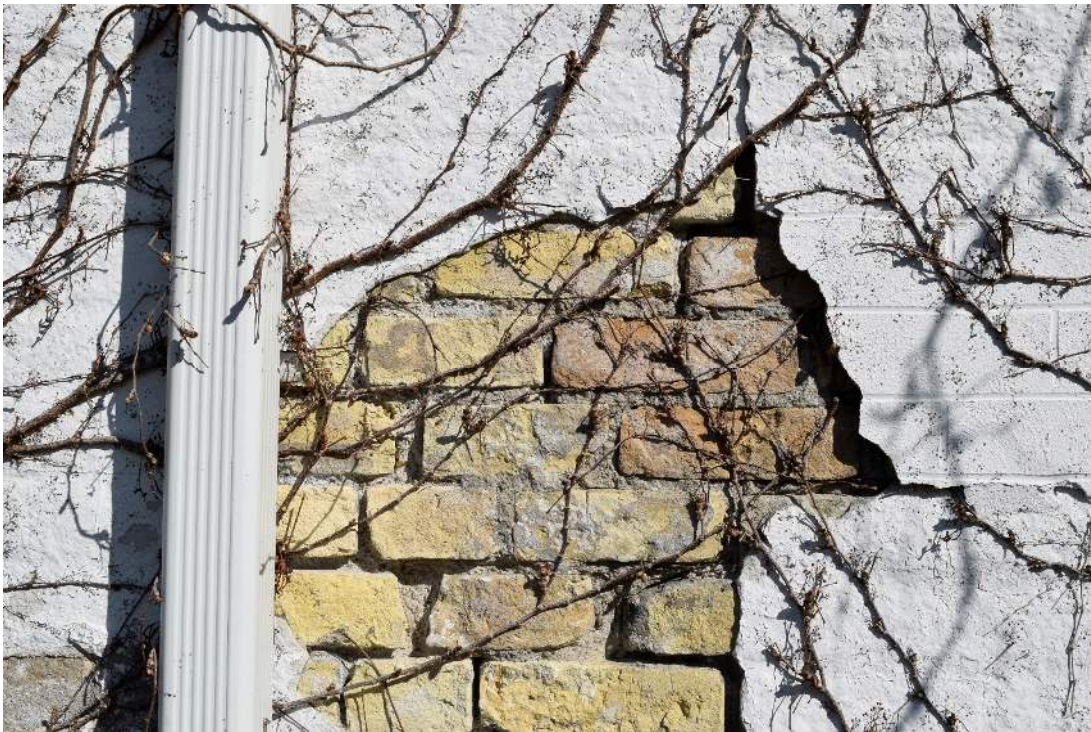
FIGURE 22: EXAMPLE OF EXFOLIATING PARGE COAT ON SOUTH SIDE OF STRUCTURE

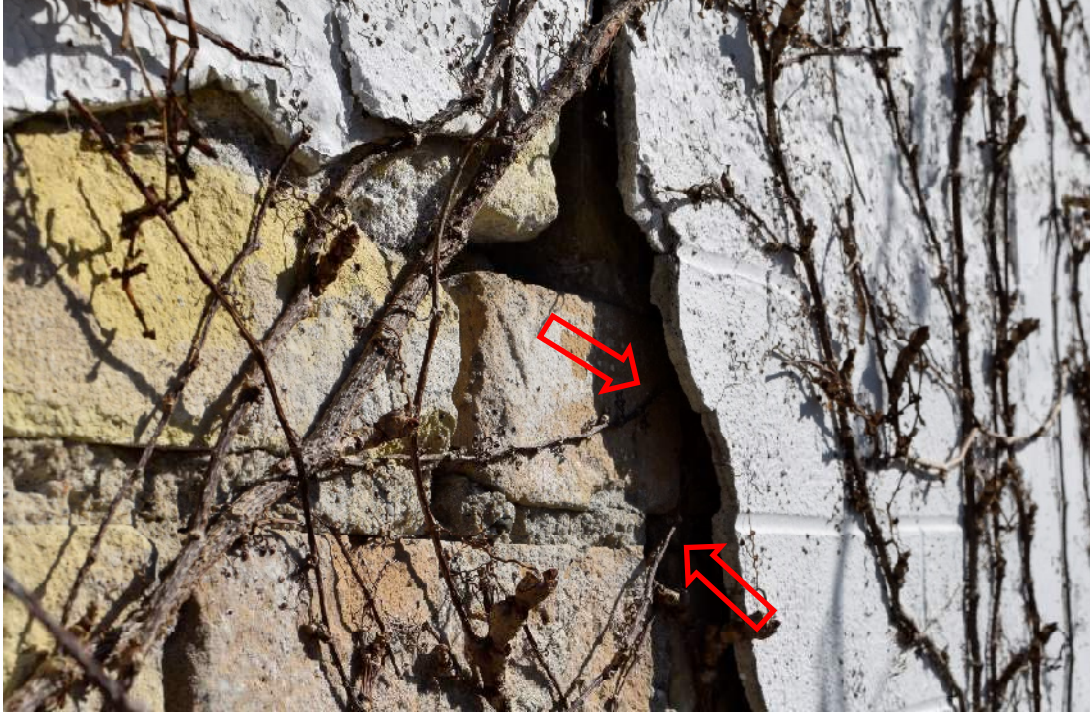
FIGURE 23: CLOSEUP OF THE SEPARATION OF PARGE COAT FROM UNDERLYING YELLOW BRICK, NOTE THE VINE RUNNER GROWING BETWEEN PARGE COAT AND YELLOW BRICK (RED ARROWS)

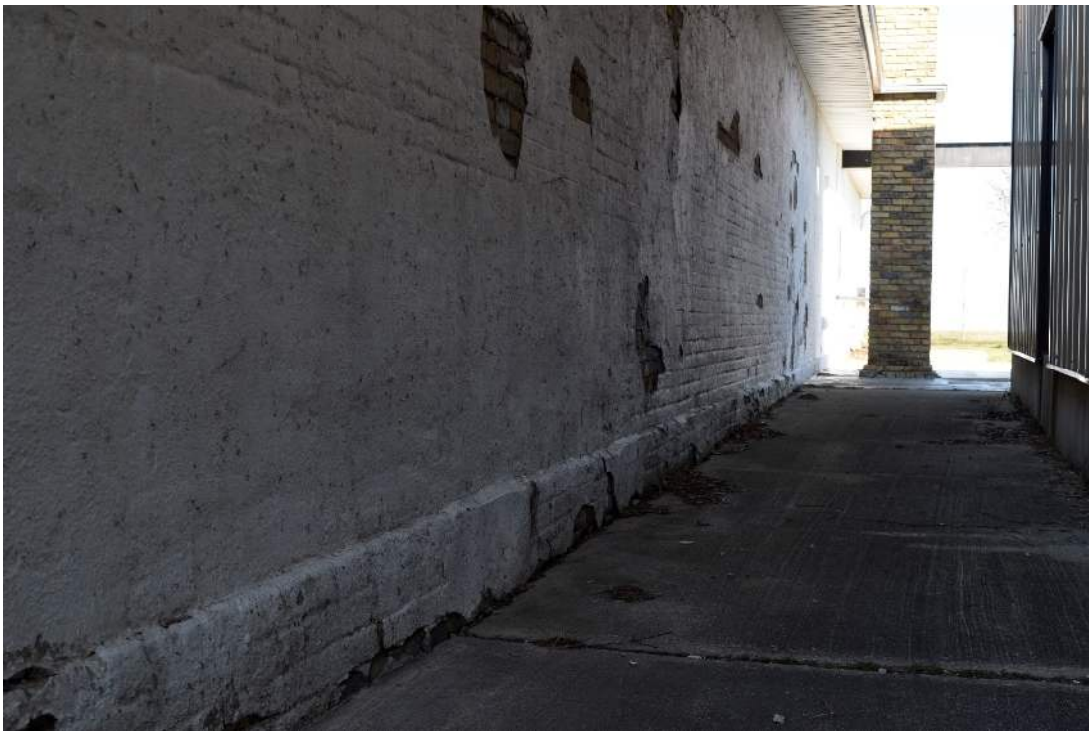
FIGURE 24: OVERALL CONDITION OF EAST SIDE OF STRUCTURE, FACING NORTH, NOTE REPEATED EXAMPLES OF PATCH WORK TO PARGE COAT AS EVIDENT BY DIFFERENT TEXTURES

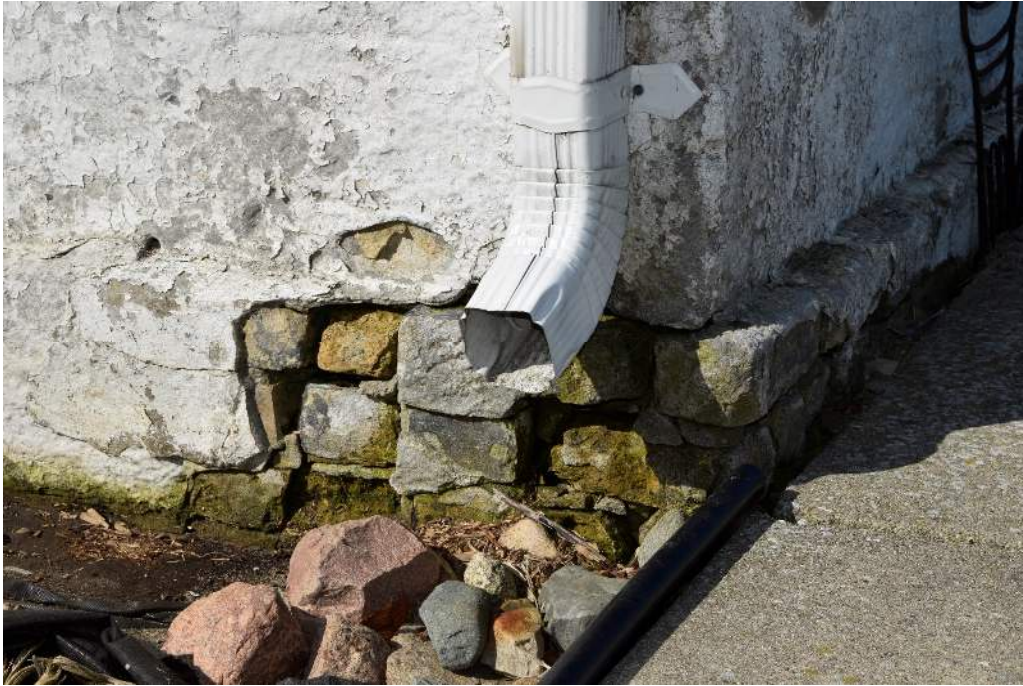
FIGURE 25: TYPICAL EXAMPLE OF DEGRADATION RESULTING FROM LACK OF WATER MANAGEMENT, EXPOSED YELLOW BRICK INDICATES STRUCTURE FOUNDATION IS OF SOFT YELLOW BRICK

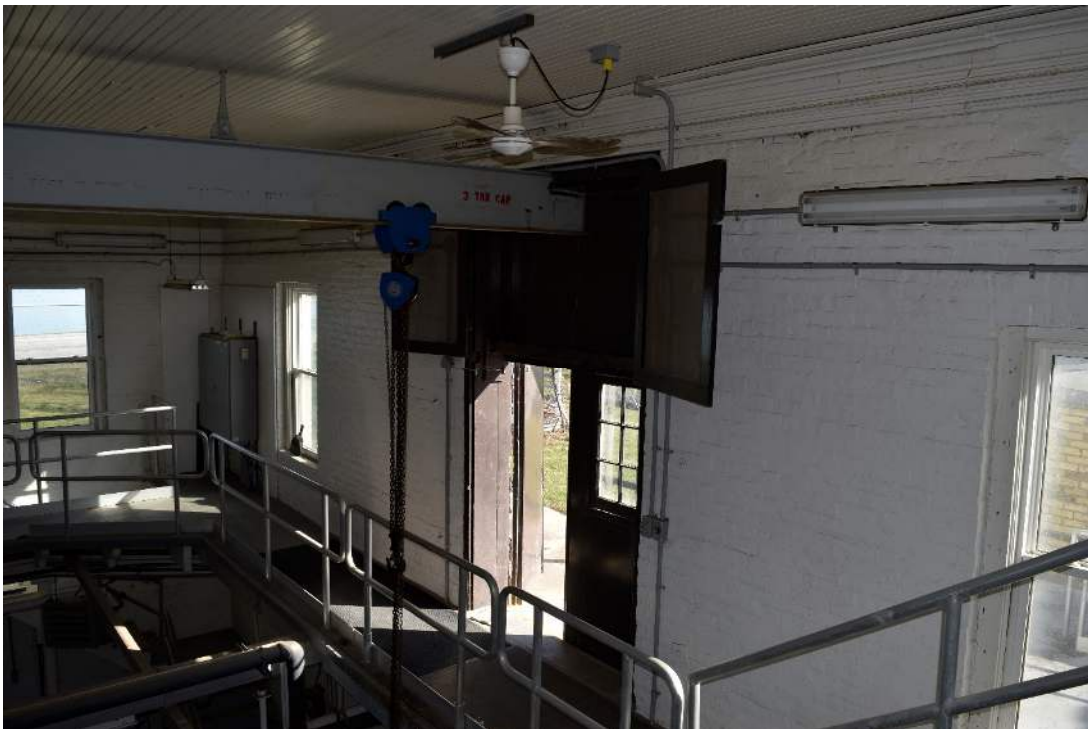
FIGURE 28: OVERSIZED HEAVY EQUIPMENT EGRESS WITH ASSOCIATED HOIST

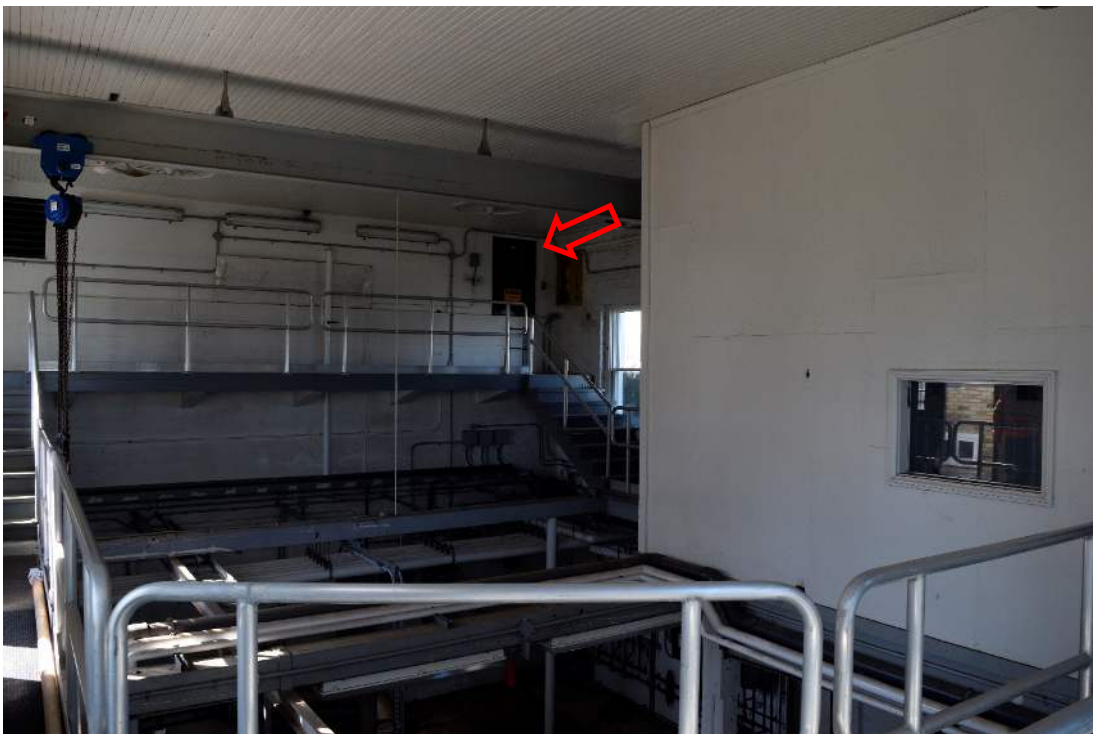
FIGURE 30: LOOKING SOUTH TOWARDS SOUTHWEST CORNER, RED ARROW INDICATED ACCESS HATCH TO ORIGINAL WATER SETTLING TANKS

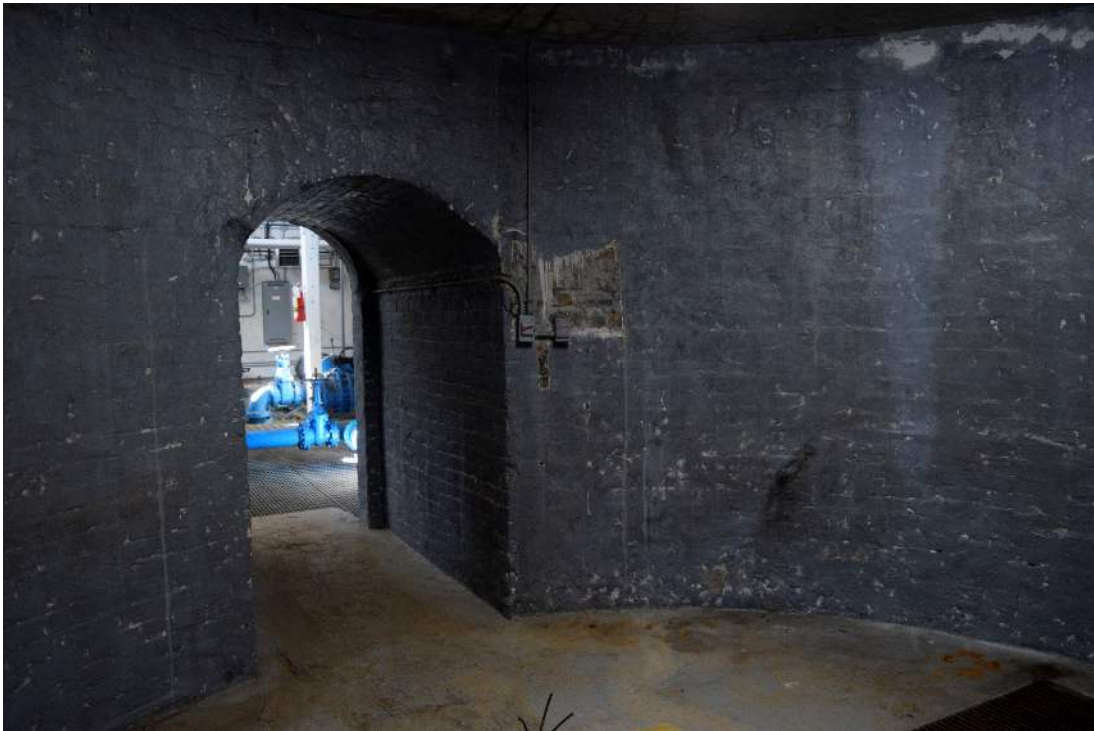
FIGURE 34: WELL VAULT AND CONNECTING PASSAGE, FACING SOUTH

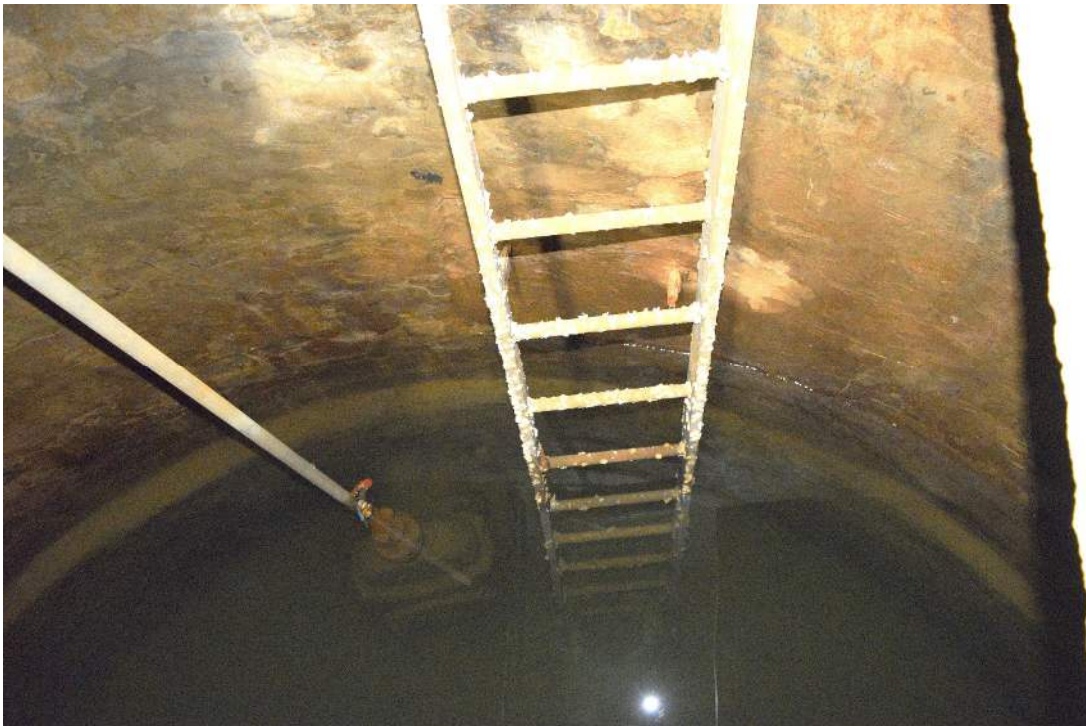
FIGURE 36: LOOKING INTO STONE LINED WELL

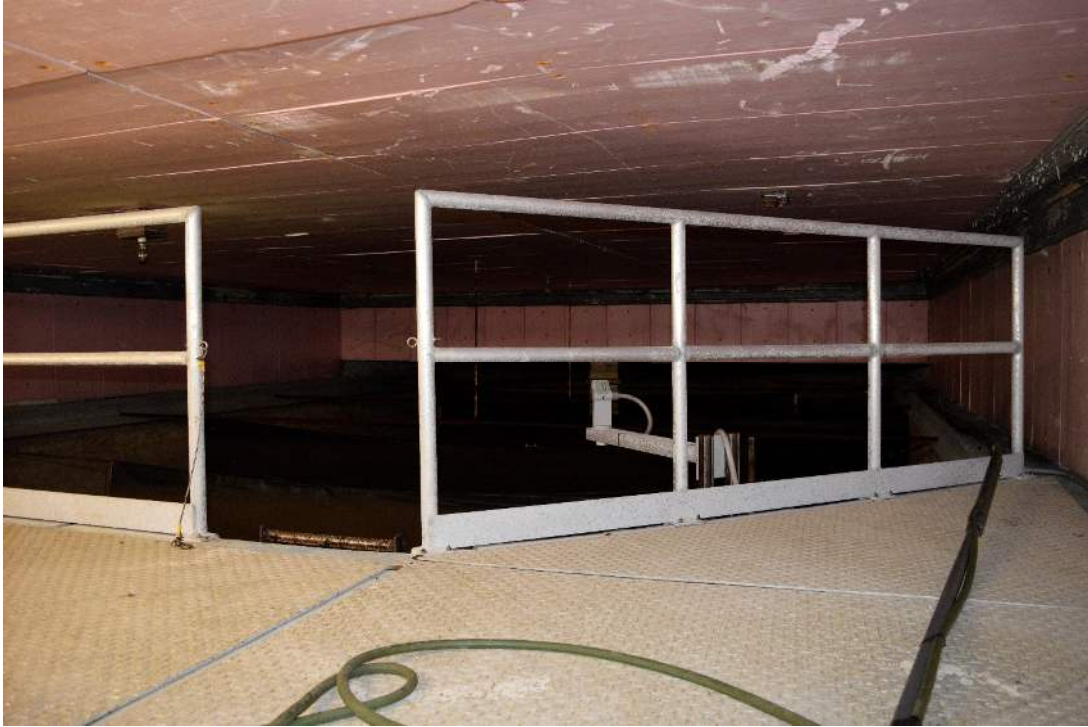
FIGURE 37: CATWALK ON NORTH END OF WATER SETTLING TANKS, FACING SOUTH

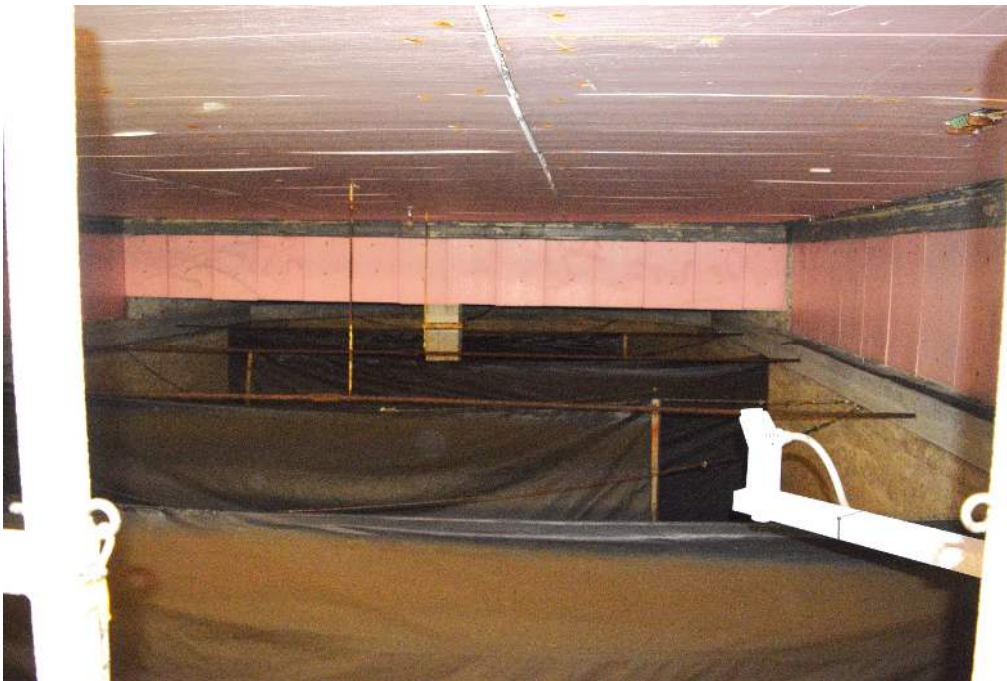
FIGURE 38: LOOKING SOUTH OVER THE WATER SETTLING TANKS

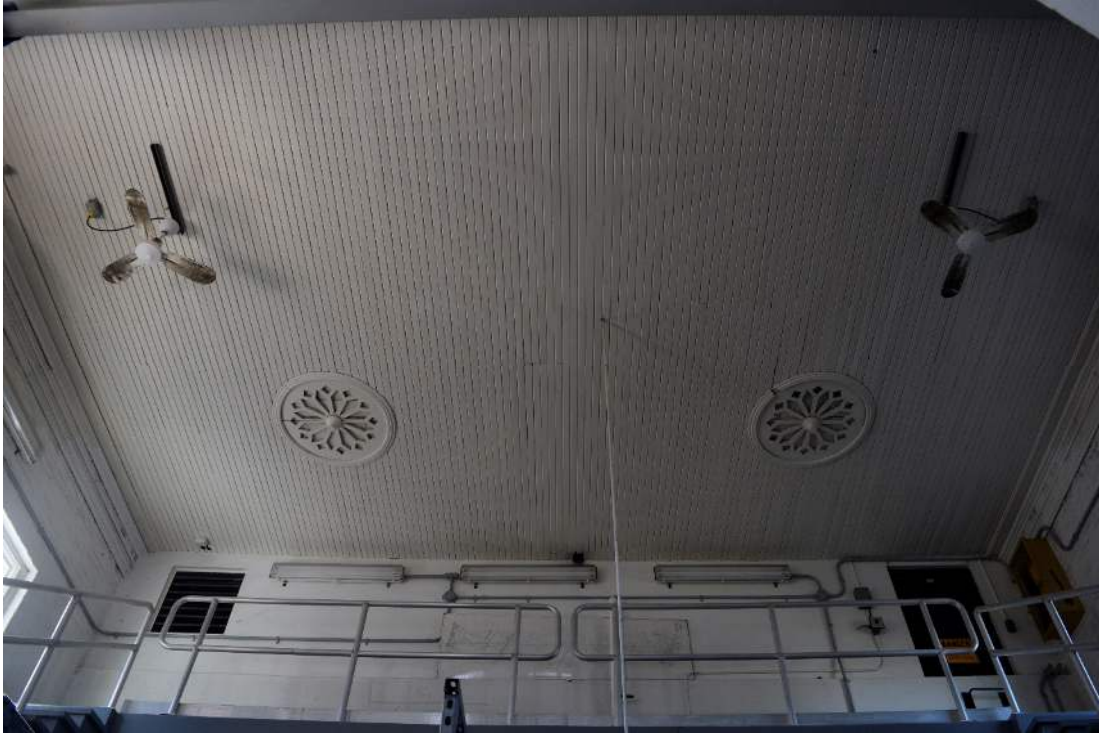
FIGURE 41: EXAMPLE OF ORIGINAL TONGUE AND GROOVE CEILING WITH DECORATIVE MEDALLIONS, SOUTH END OF STRUCTURE

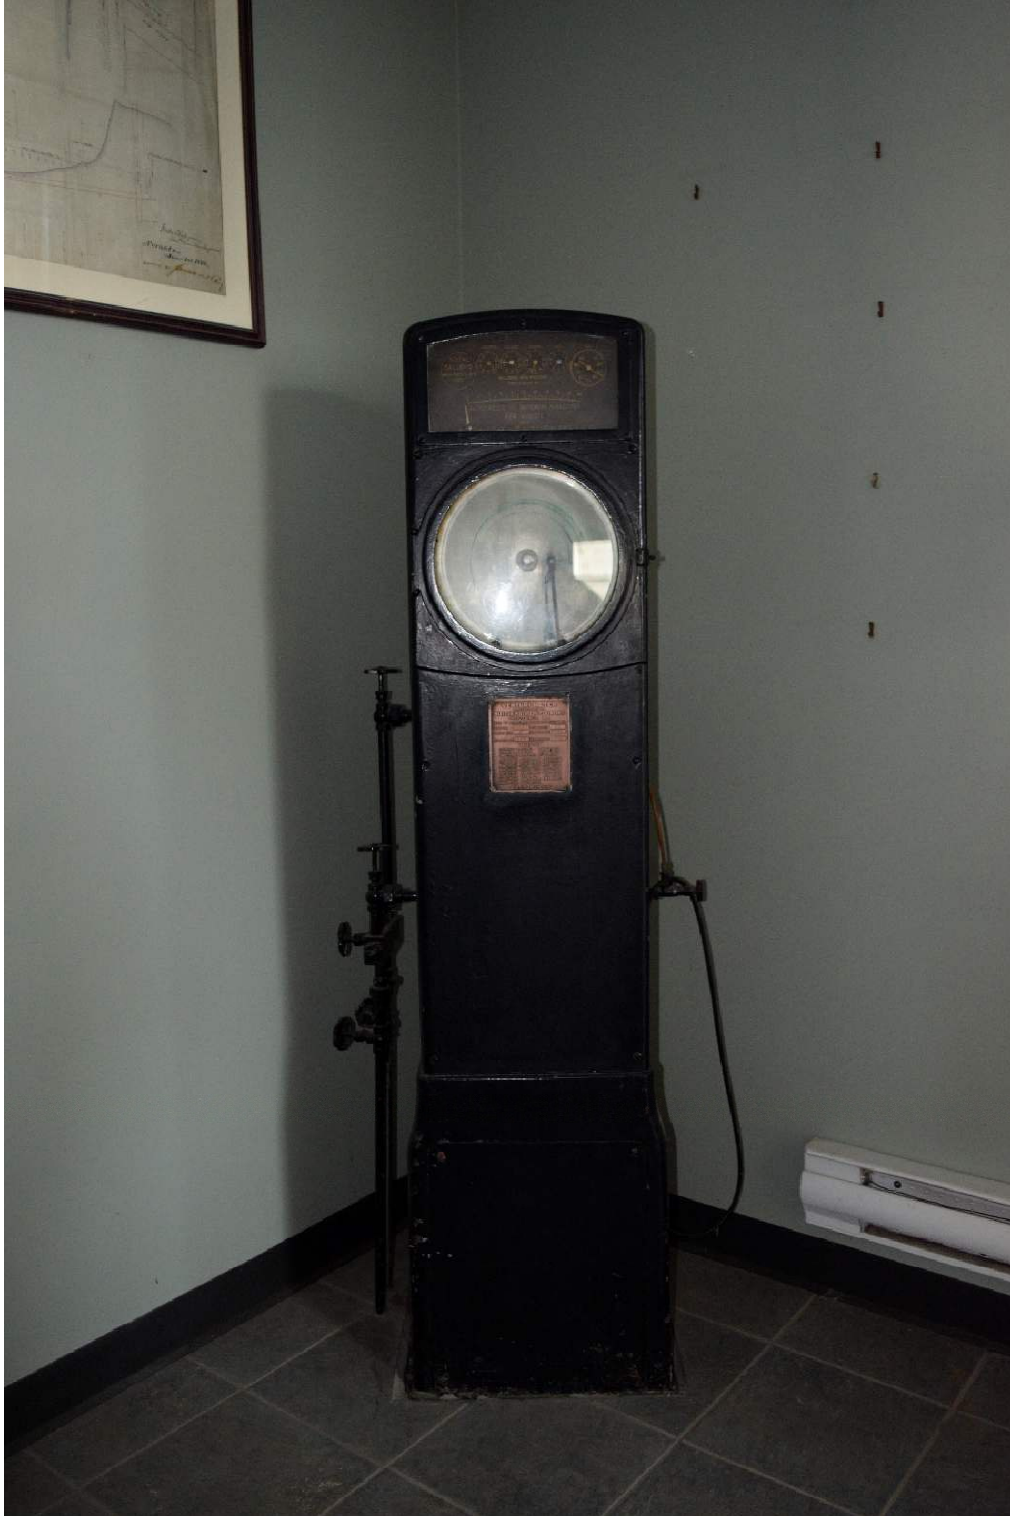
FIGURE 43: ORIGINAL VENTURI FLOW METER IN NORTHWEST CORNER OF OFFICE

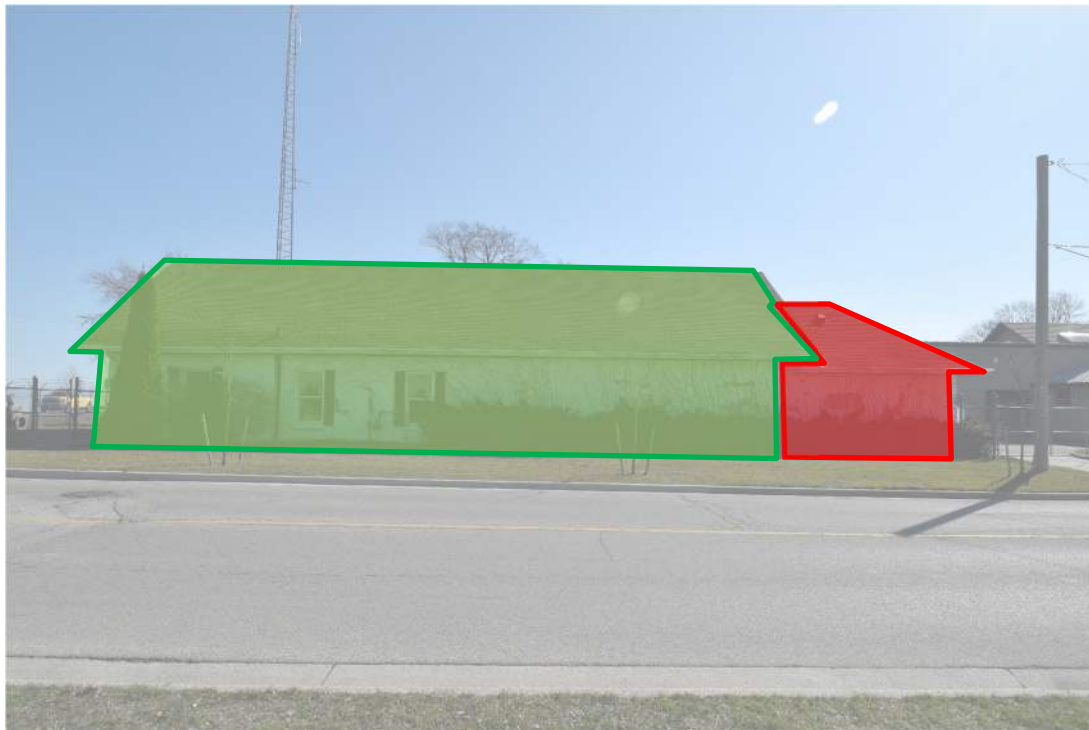
FIGURE 44: DEVELOPMENT SEQUENCE, GREEN REPRESENTS ORIGINAL 1896 STRUCTURE AND RED REPRESENTS 1929 ADDITION
