Town of Petrolia

Bright's Grove Water Treatment Plant Intake Replacement

Class Environmental Assessment Project File Report

T001646A

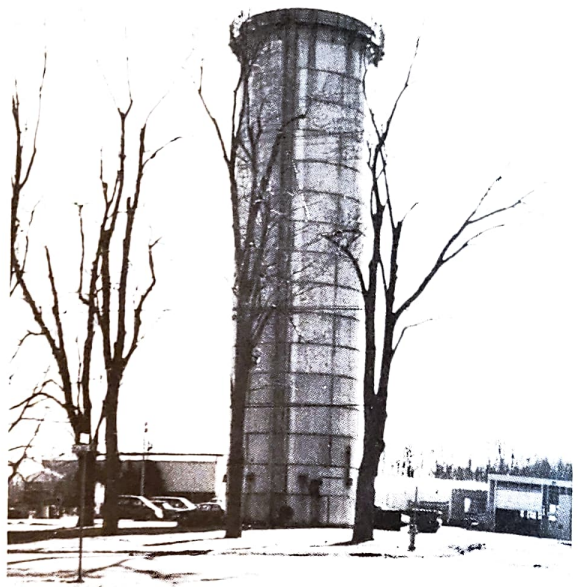
Old Water Tower 1896

Late January 1897 the first Petrolia water tower was up and filled with water. It was 25 feet in diameter and 85 feet high. This tower is still seen on Centre Street. It is the steel one with the decorative fence around the top. Currently it is used as a backup tower. By November of 1896, the pumphouse and engineers house at the lake were completed.

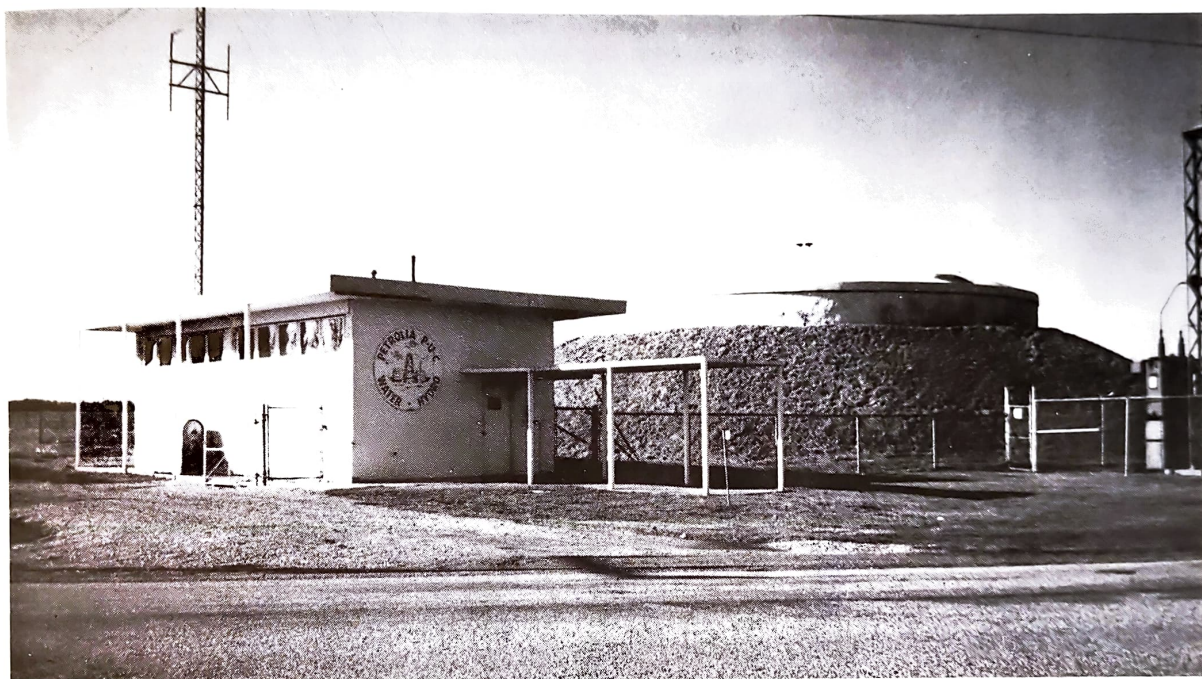
Reservoir & Pumping Station

After much negotiation and political decision making, the town undertook to add a pumping station and holding tank on Confederation Line, about halfway between Petrolia and Brights Grove. This gave the whole system more stability. A new radio system improved communications between the main office in Petrolia and the Operators in Brights Grove. This project was supported by selling water to Watford and Wyoming from the Mandaumin pumphouse. There was a separate pump at the station to send the water east on a line to service these communities. The new reservoir and pumping station were officially opened in 1962.

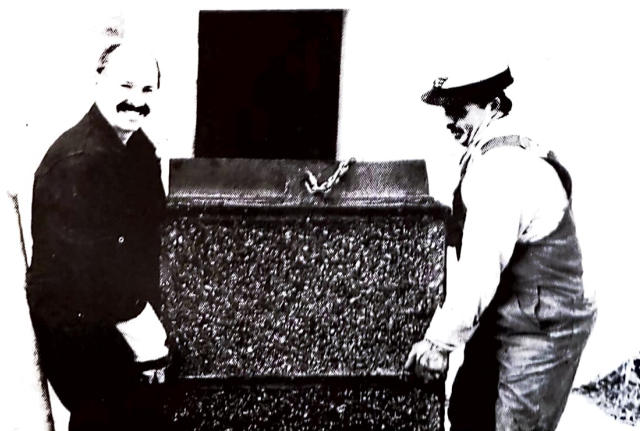
Marc Trottier and Mike Young with screen from intake well coated with Zebra Muscles.

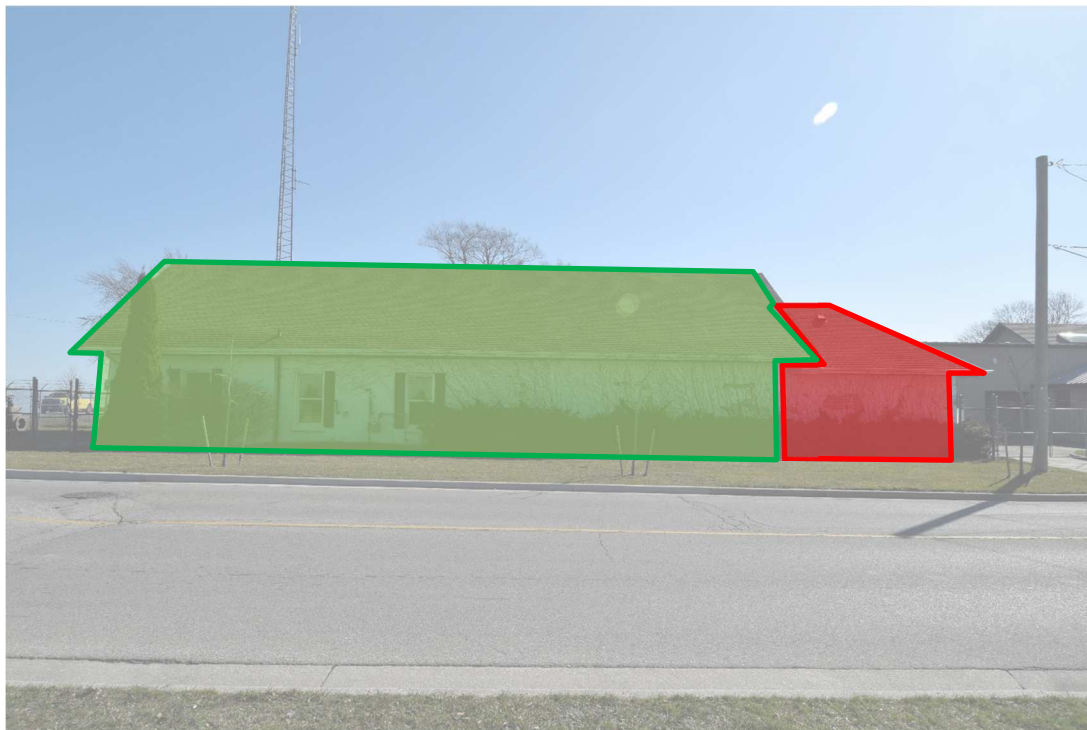
FIGURE 1: DEVELOPMENT SEQUENCE, GREEN REPRESENTS ORIGINAL 1896 STRUCTURE AND RED REPRESENTS 1929 ADDITION

The original 1896 'Petrolia Water Works' pump house located at 2701 Old Lake Shore Road is in fine overall condition. The structure retains its original rectilinear form with gable roof line and 1929 rear addition with truncated hip roof. The exterior of the structure has been subject to cosmetic alterations including the removal of window opening and the enlargement of window openings to facilitate equipment egress. The exterior appearance has also been altered through the application of a parge coat (thin mortar layer) over the original soft yellow brick. This parge coat has subsequently been subject to multiple layers of paint. The painting of the parge coat has resulted in the trapping of moisture resulting in degradation of the yellow brick and exfoliation of the parge coat. The presence of clinging vegetation is contributing to the degradation of the structure as the shading provided by the vegetation slows the evaporation of moisture and the plants aerial roots act like small wedges in any exterior cracks. The structure's original windows and front door have been recently replaced and the decorative gable end woodwork and cupola roof vents have been removed.

Evidence of upgrades to the structure are evident by way of the addition of a heavy equipment egress on the east side of the structure. The equipment egress door retains its as-built design including integrated standard door and divided light window. The interior of the structure has undergone equipment upgrades and the addition of a water settling and chlorination tank but retains its original crown molding, tongue and groove ceiling, and decorative medallions. Overall, the structure presents as a fine example of late 19th century industrial design.

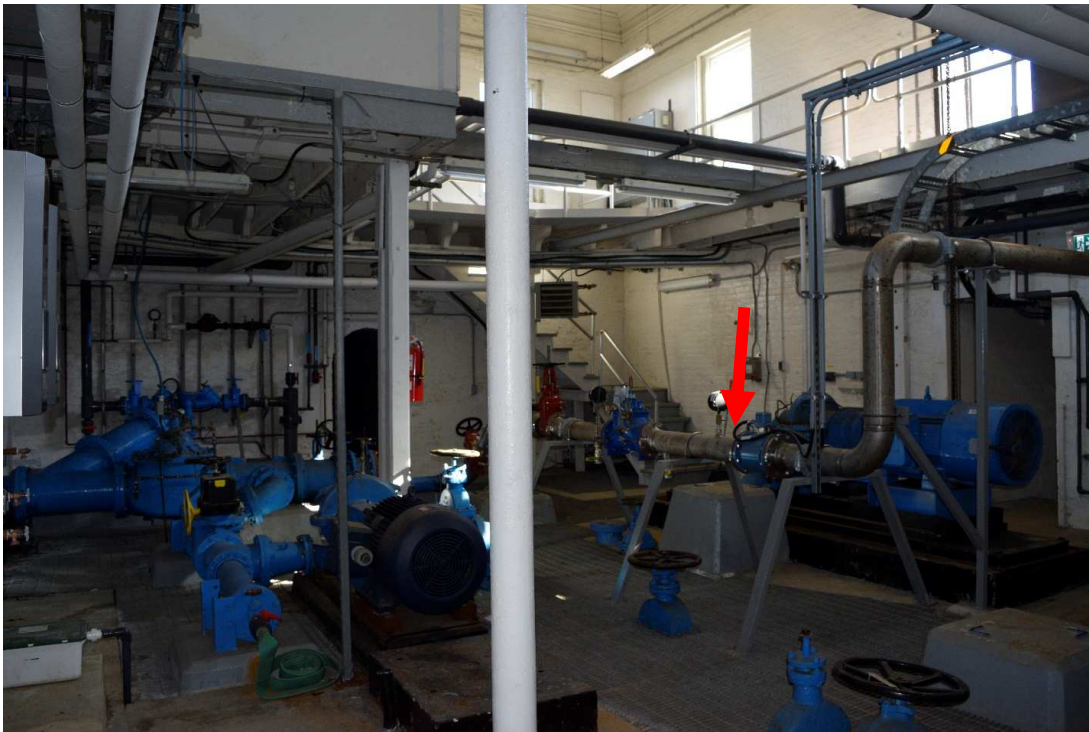
FIGURE 2: BELOW GRADE EGRESS OF WATER LINES WILL OCCUR IN THE GENERAL LOCATION OF ARROW

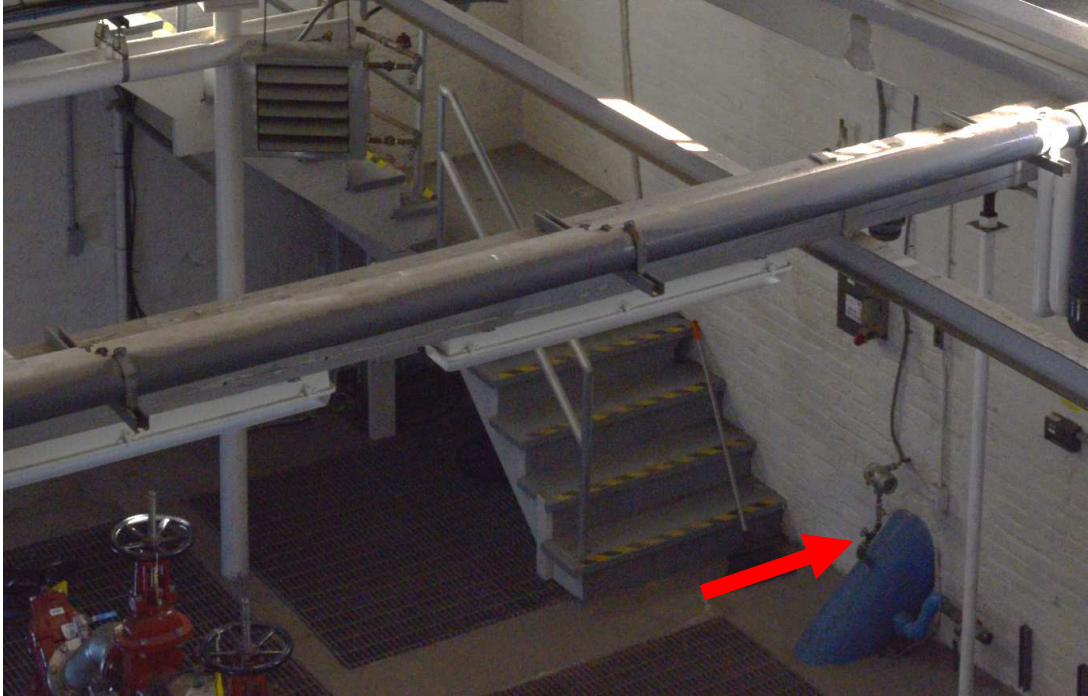
FIGURE 3: CLOSE UP OF EXISTING PIPING RUNNING THROUGH FOUNDATION IN SAME LOCATION PROPOSED ALTERATIONS

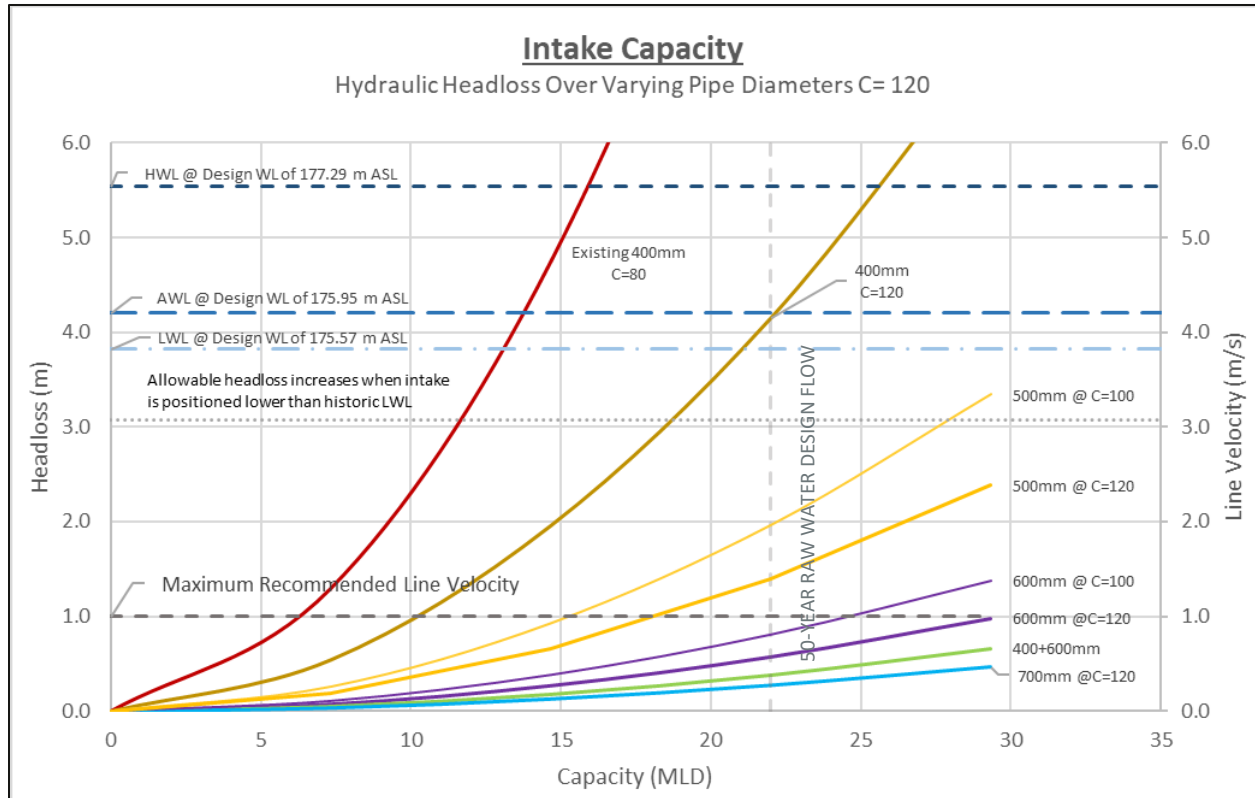
Figure 2-2: Intake Velocity and Capacity for Varying Pipe Sizes

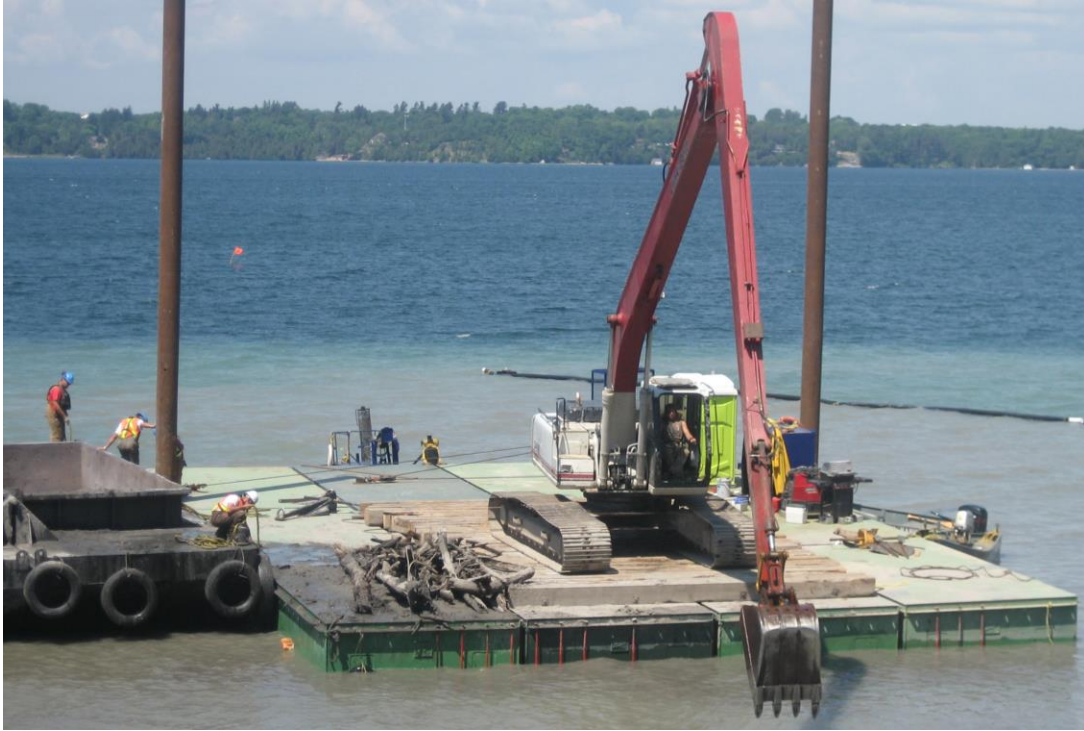
Figure 2-6: Floating Dredging Equipment

An open-cut marine trench will be dredged in the lake bottom along the entire pipe alignment (400 m) from the shoreline out to the offshore intake structure position. This trench will be excavated using floating dredging equipment as pictured in Figure 2-6.

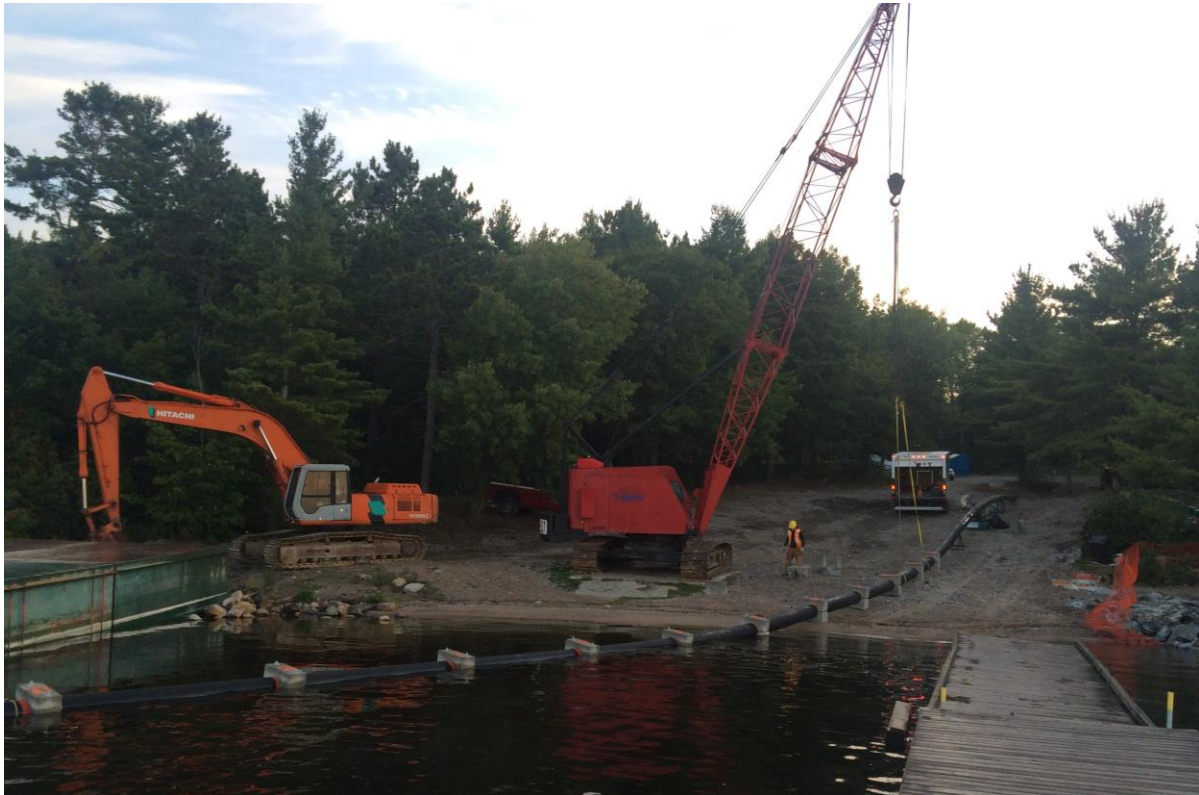
Figure 2-7: Example onshore installation of intake pipeline

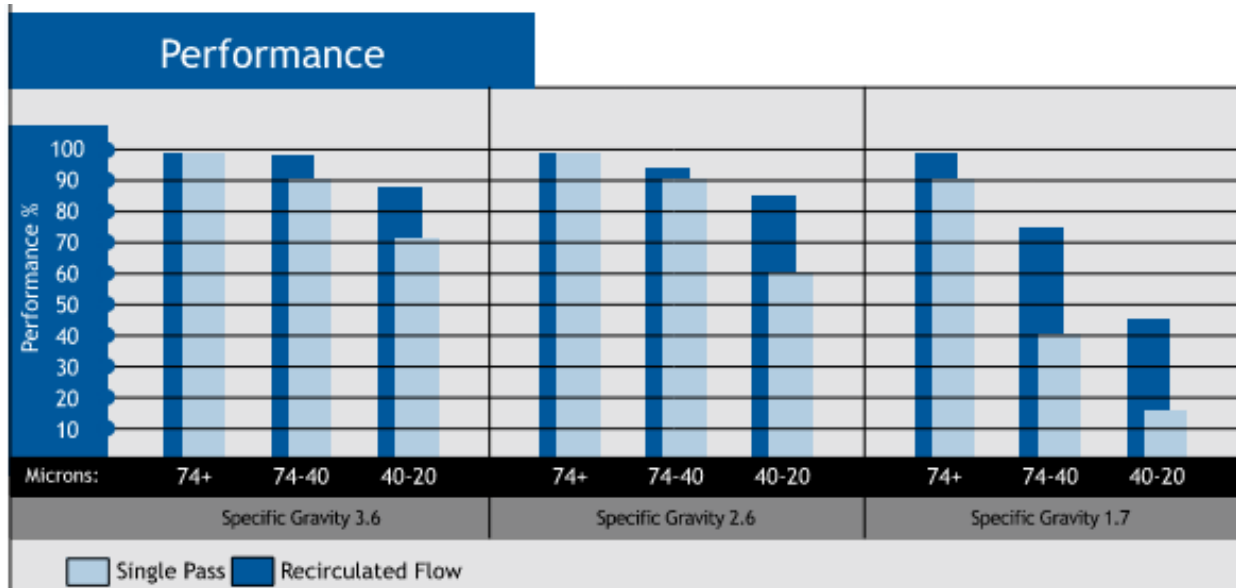
Figure 4-4: LAKOS Municipal Sand Separator Particle Removal Efficiency by Micron (Appendix D)

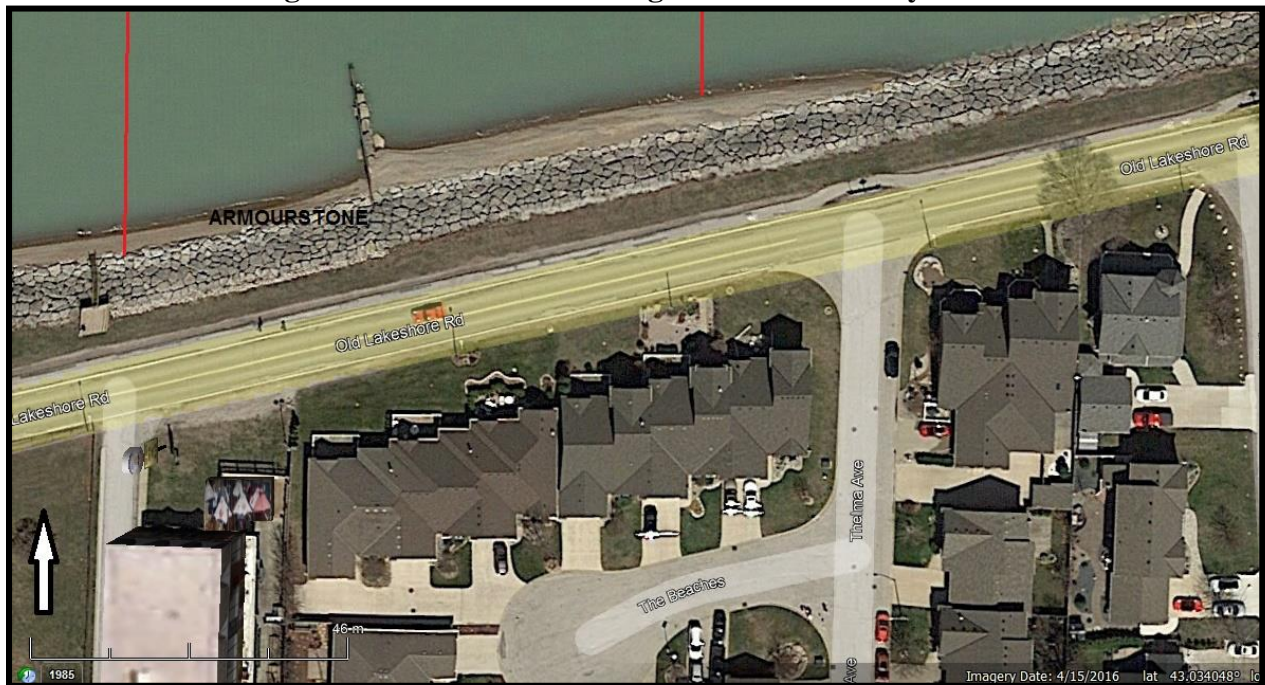
Figure 3: Armour stone along Shoreline of Study Area

The Study Area consists of an area of approximately 19 hectares in area. The shoreline of the Study Area measures approximately 160 m and the Study Area extends out approximately 383 m into Lake Huron. The shoreline is highly modified to prevent erosion and is lined with armour stone. The first approximate 53 metres of shoreline, from the west end has the armour stone extending 13 metres from the top of the bank to the in water edge. The remaining 107 metres is lined with a width of armour stone of between 7.5 to 8 metres. In this latter section, there is a thin strip of sandy beach, but it is unlikely that any of the original shoreline exists, except under the armour stone (Figure 3).

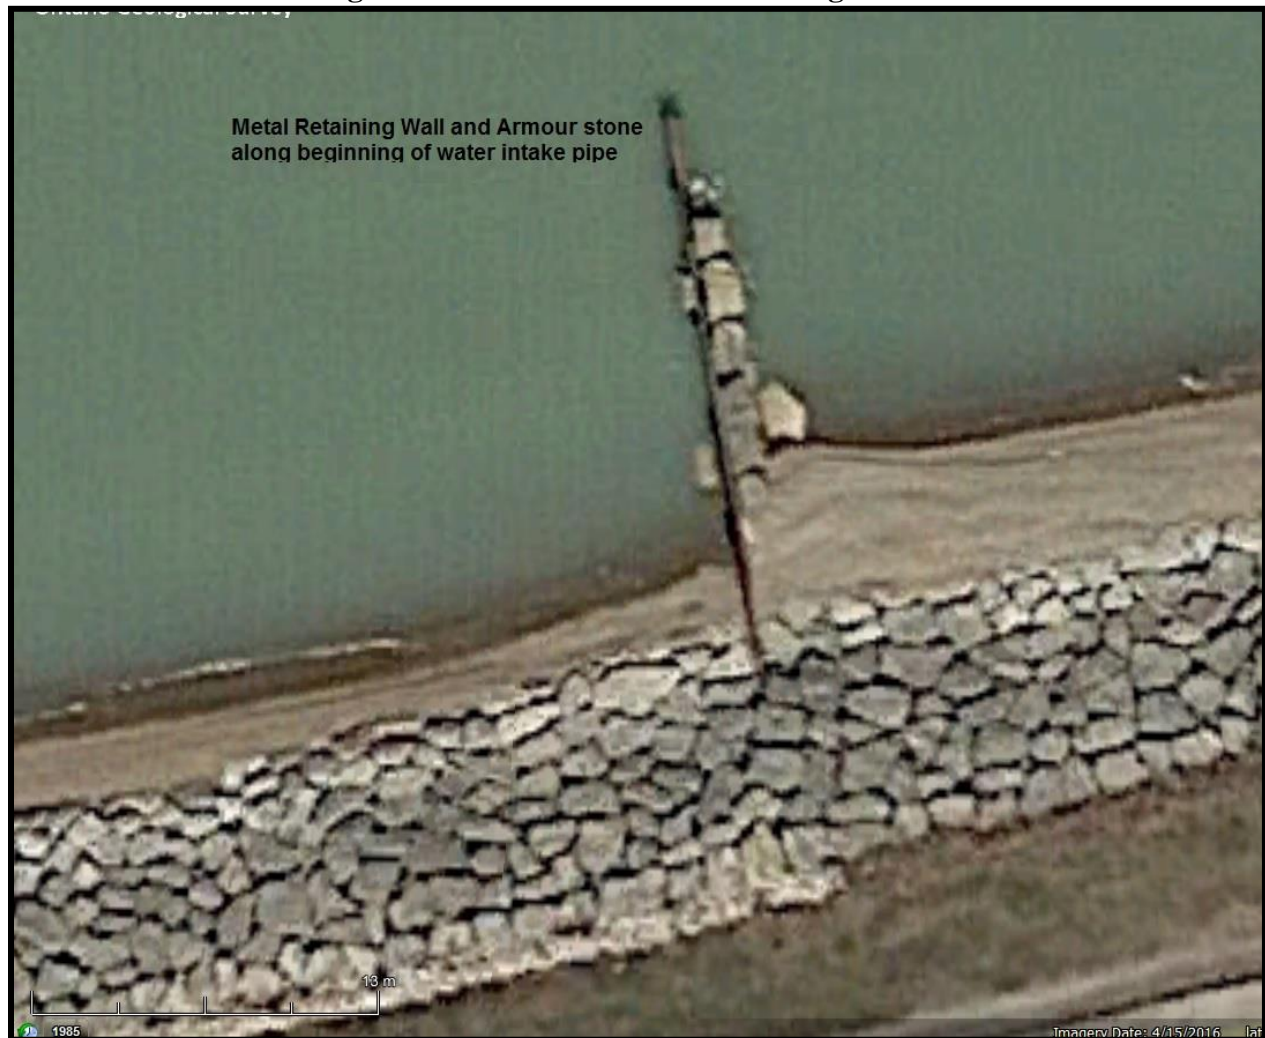
Figure 4: Metal Sheet Wall at Existing Intake

There is one area marking the current water intake area at the shoreline delineated by sheet metal and armour stone extending out into the lake for a distance of 19.36 metres from the edge of the armour stone (Figure 4).

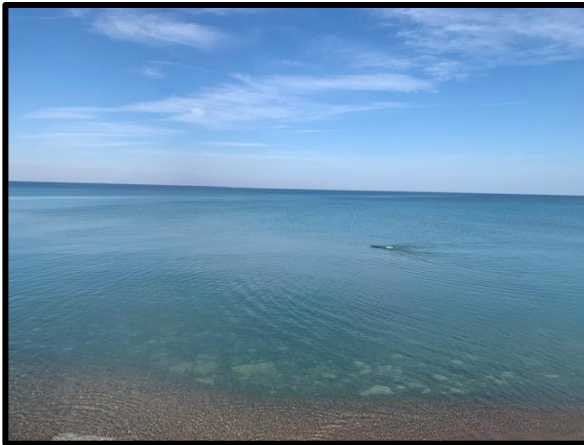
Image 9: AUV conducting sidescan and magnetometer survey

The sidescan sonar and magnetometer survey were conducted by an AUV (autonomous underwater vehicle, and towed magnetometer) (Image 9–Image 10). Survey was conducted in 30 m intervals, and a chase boat (kayak) was used to ensure that the AUV remained on course. Figure 6 illustrates targets located in the side scan and magnetometer survey.

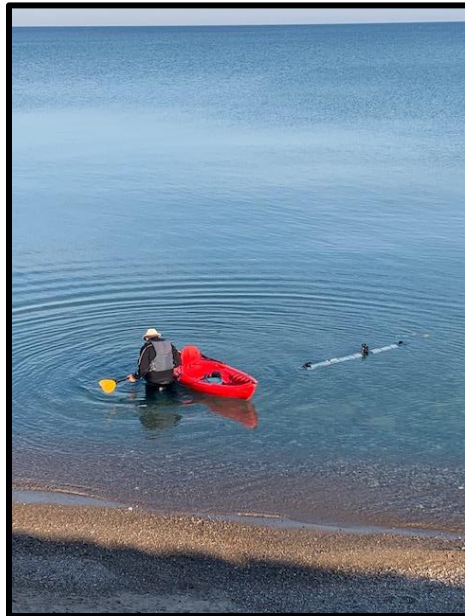
Image 10: Chase Boat and AUV
