Town of Petrolia

PRELIMINARY ASSET MANAGEMENT PLAN

December 6, 2013

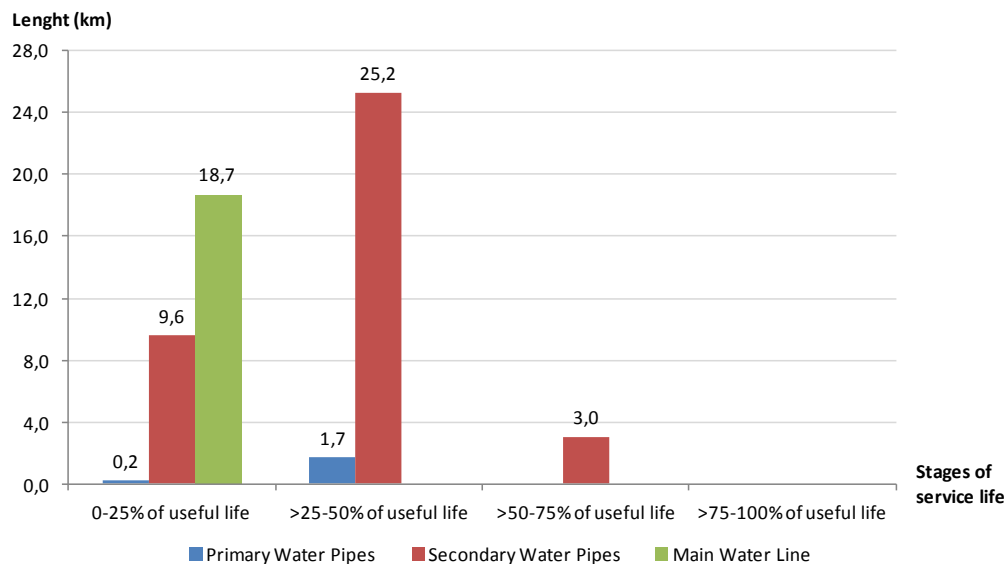
Almost all water pipes in Petrolia are made of cast iron or PVC. The mean expected useful life of water pipes was agreed upon 75 years with the Town staff. Comparing the age of each pipe to its expected useful life, the portrait illustrated by Figure 2 is obtained.

Figure 2: Water Pipes Age compared to their Expected Useful Life (75 years)

The main water line is only in its first stage of service life, aging between 0 to 25% of its useful life, while most of the primary and secondary networks did not reach more than 50% of their useful life. The portrait is similar for hydrants, as shown by Figure 3.

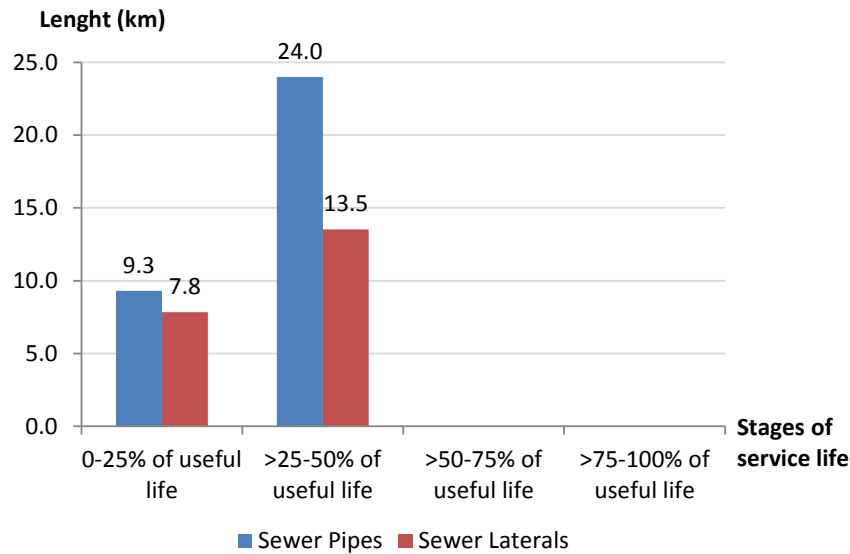
Almost all sewer pipes in Petrolia are made of PVC, asbestos cement or concrete. The mean expected useful life of water pipes was agreed upon 100 years with the Town managers. Comparing the age of each pipe to its expected useful life, the portrait illustrated by Figure 5 is obtained.

Figure 5: Sewer Pipes Age compared to their Expected Useful Life (100 years)

It can be seen that the sewer pipes and laterals network of the Town did not yet reach more than 50% of its useful life. The portrait is similar for manholes, as shown by Figure 6.

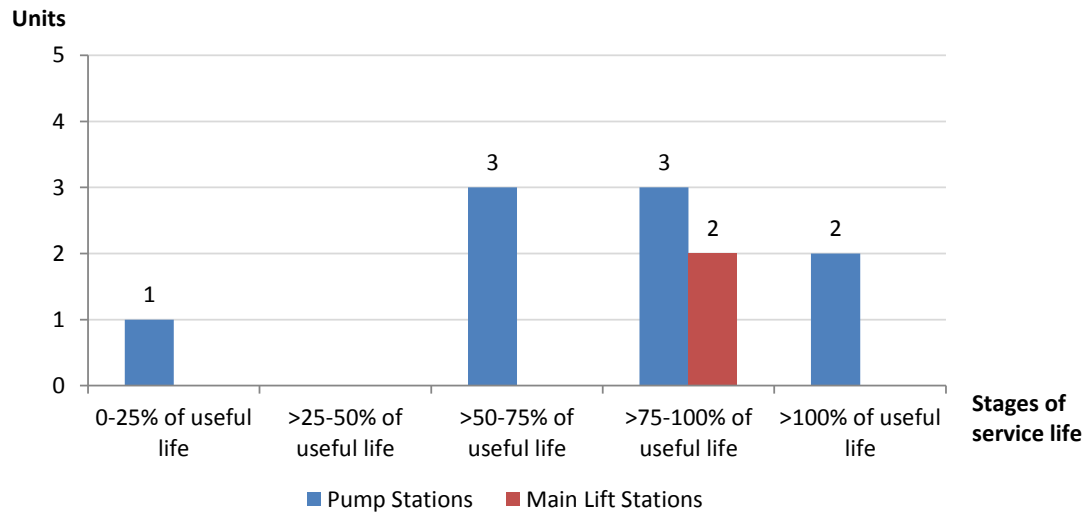
The mean expected useful life for the pump stations is 25 years according to the Town managers, while for the main lift station, the structure should last 40 years but the equipment only 20 years. Comparing the age of each pump/lift station to its expected useful life, the portrait illustrated by Figure 7 is obtained.

* There is one pump station not represented on this graph since its in-service date is unknown.

Figure 7: Pump Stations Age compared to their Expected Useful Life Pump Stations (local pump station: 25 years; main lift station: 40 years)

Most of the pumping stations as well as the two main lift stations will reach 100% of their useful life within the next 5 years, and two more pumping stations are already above 100% of their useful life. Moreover, the equipment of the two main lift stations should have undergone major rehabilitation and/or replacement many years ago.

Results show that all pumping stations offer a fair to poor condition and performance, and that funding is not sufficient to maintain and renew them. Moreover, it seems also that the Town has capacity issues with the main lift stations. During interviews, it has been mentioned that 25% of the pump stations are in poor condition and require immediate attention, and that for the two main ones (lift stations), upgrades are recommended within the next five years. These results and comments are reflected as well in the age vs. useful life portrait illustrated in Figure 7.

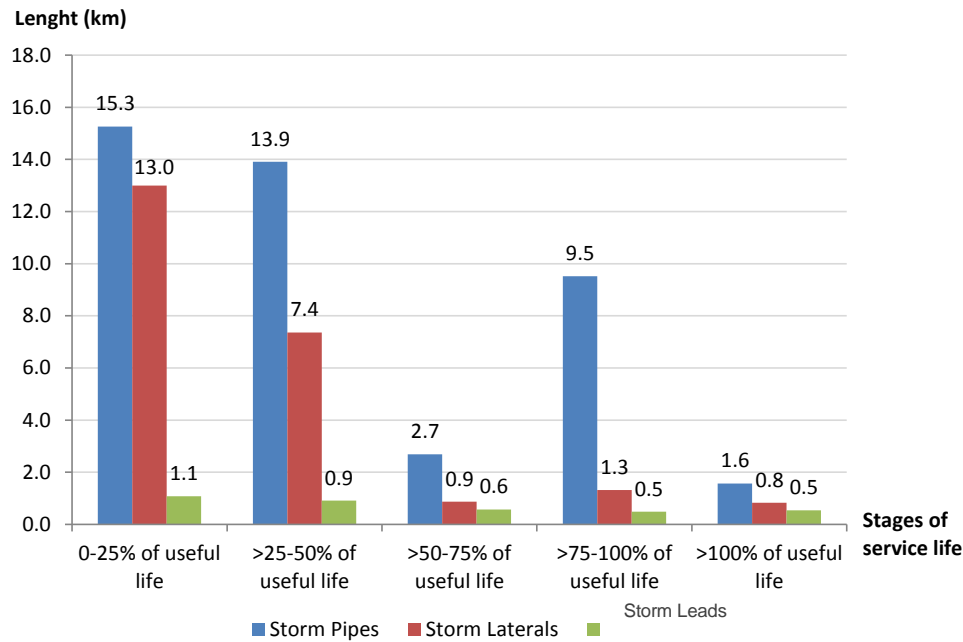
Most of the storm pipes in Petrolia are made of tile or concrete. The mean expected useful life of storm sewer pipes, laterals and manholes was agreed upon 100 years with the Town managers, while storm leads and catch basins are expected to last 50 years. Comparing the age of each pipe and accessory to its expected useful life, the portraits illustrated by Figure 9 and Figure 10 are obtained.

Figure 9: Storm Pipes Age compared to their Expected Useful Life (pipes & laterals: 100 years; leads: 50 years)

It can be seen that almost 15 km of storm sewers (including laterals and leads), and 30% of the catch basins in Petrolia are at or past 100% of their expected useful life. On the other hand, all manhole structures are still within 50% of their expected useful life.

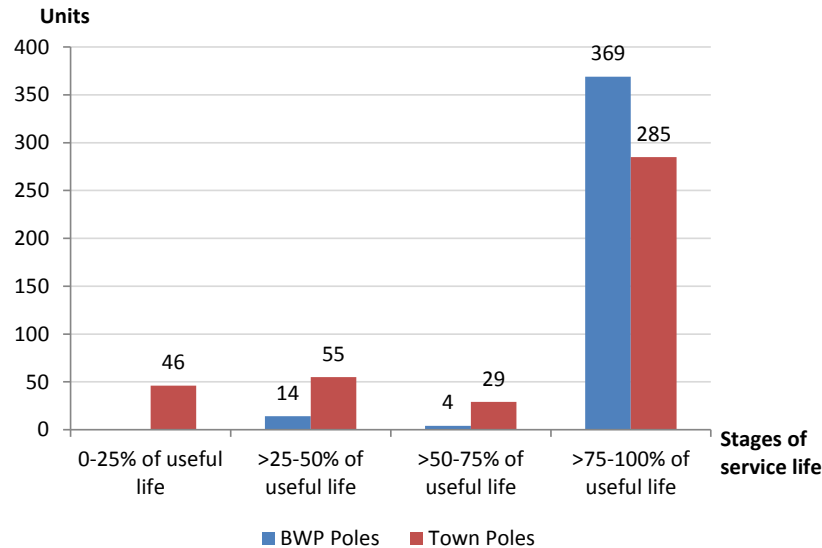
The streetlights poles age can also be compared to their expected useful life (25 years), to obtain the following portrait.

Figure 13: Streetlights Poles compared to their Expected Useful Life (25 years)

A large amount of the streetlights poles are in the last stages of their useful life and, as such, it is anticipated that this asset class will require a significant amount of investment in the near future. However, the actual condition of all these poles should be assessed prior to initiating a replacement program.

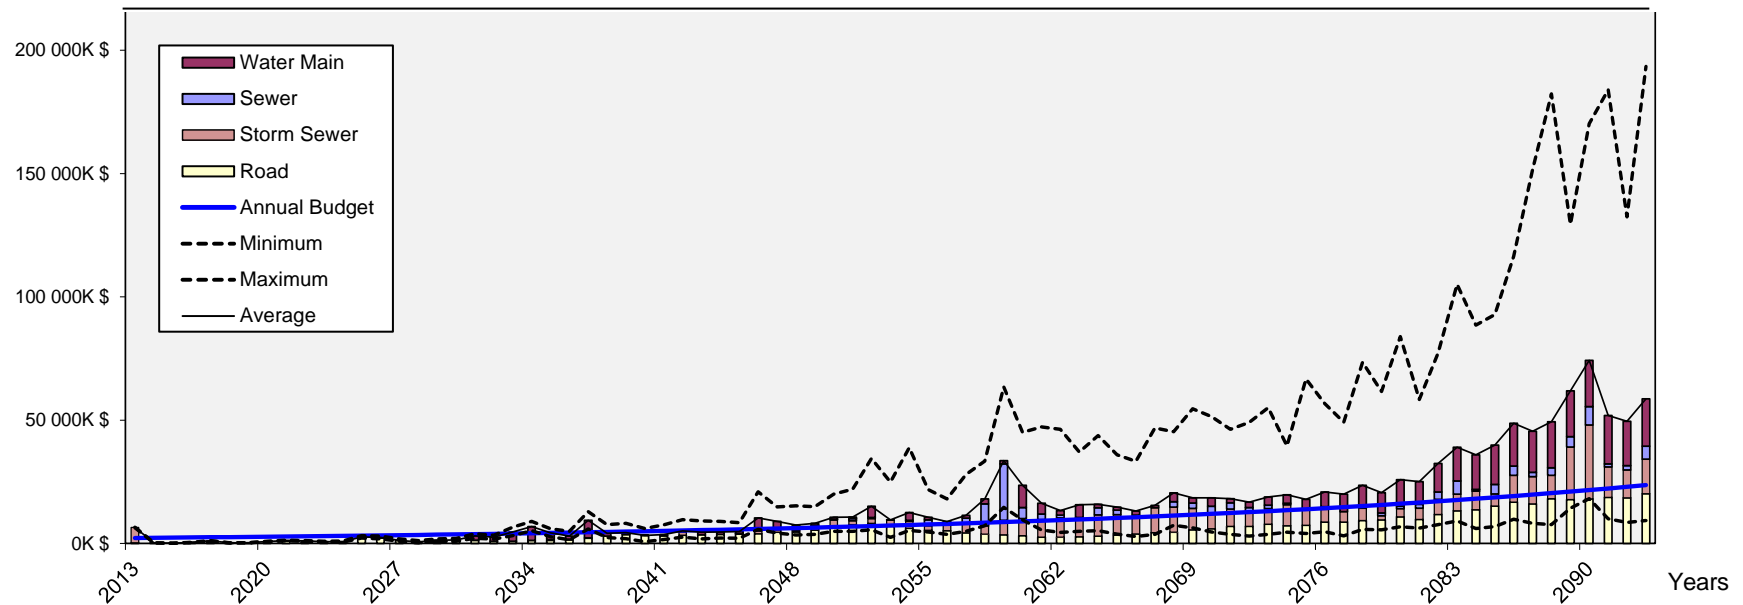
In terms of financial planning, figure 21 shows the portrait over the next 80 years, while figure 22 shows a close-up of this portrait for the next 20 years.

Over 80 years, the following amount of investment (2013 present value) would be necessary: \$18.14 million for the water linear network, \$4.78 million for the wastewater linear network, \$18.22 million for the stormwater linear network, and \$29.64 million for the roads, for a total amount of \$70.78 million. This amount of investment represents an annual budget of \$2.22 million (2013 present value), which increase each year to account for inflation.

Figure 21: Final Scenario: Financial picture over the next 80 years

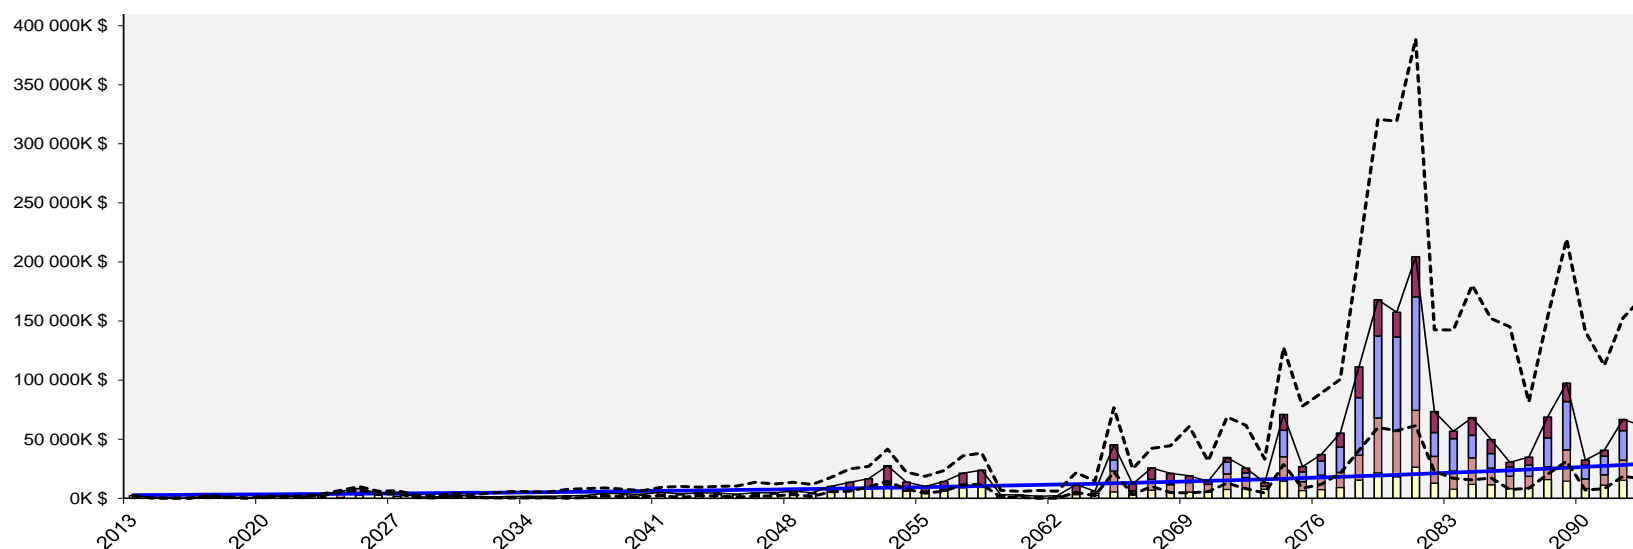
In terms of financial planning, the scenario without rehabilitation requires lower investments on the short term, but requires significantly more investment after only 10 years. This fact is also illustrated by the annual budget required (in 2013 present value, increasing annually with inflation) which is \$2.74 million for the scenario without rehabilitation versus \$2.22 million for the final scenario, which includes rehabilitation activities.

Figure 24: Scenario Without Pipes Rehabilitation: Financial picture over the next 80 years

To go further into our analysis and to illustrate the advantage of including rehabilitation activities into financial planning, a management scenario in which only replacement activities are allowed on pipes was tested. All other parameters and decisional criteria were kept the same as for the final scenario presented above. For this scenario without rehabilitation, Figure 23 shows the linear impacted throughout the years for each asset group, while Figure 24 illustrates the financial portrait over the next 80 years and Figure 25, a close-up of this portrait for the next 20 years.

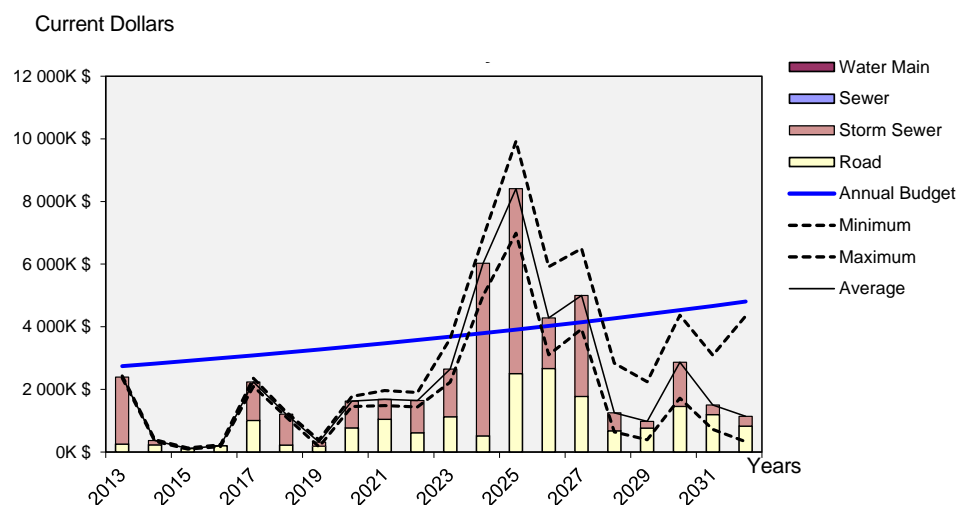
Figure 25: Scenario Without Pipes Rehabilitation: Financial picture over the next 20 years

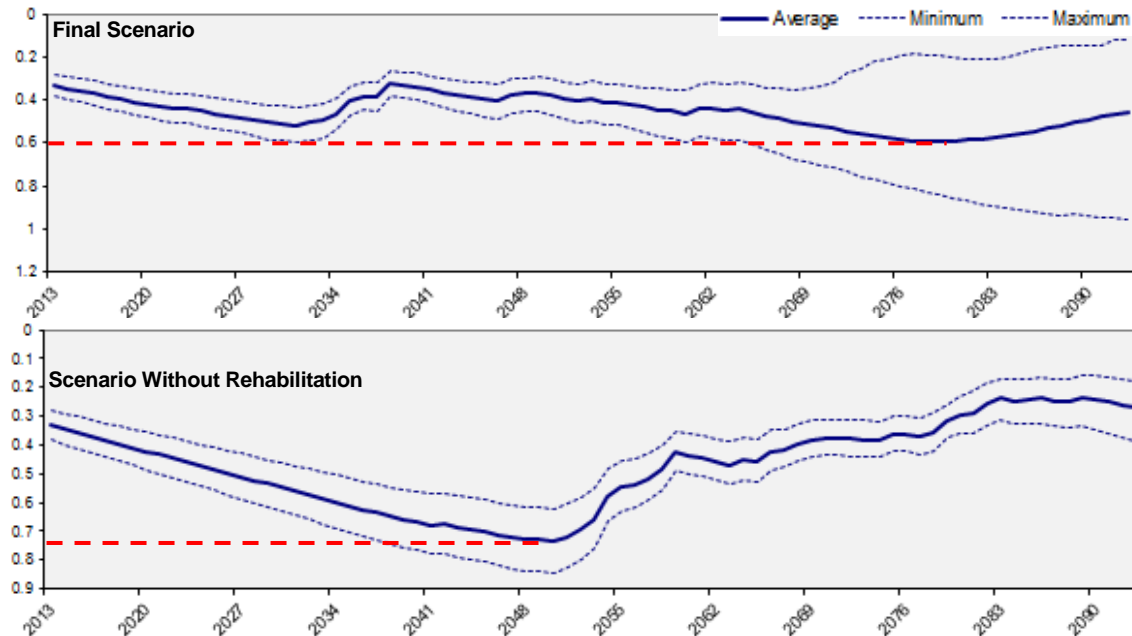
Therefore the financial advantages of doing rehabilitation activities throughout the useful life of pipes were shown, not to forget that proceeding with rehabilitation activities extend the period of time between the renewal activities, which imply much more inconvenient for the citizens than are rehabilitation activities. Also, by including rehabilitation activities it ensures a better level of service throughout the useful life of the pipes, as shown by figure 26 below.

Figure 26: Fluctuation of the level of service for water linear network over the next 80 years: Comparison between the final scenario and the scenario without pipe rehabilitation

Moreover, the difference between these two scenarios would probably be even bigger if the analysis had been done based on the real condition of pipes. The costs associated with an annual inspection program are much lower than what can be saved over the years by planning every renewal and rehabilitation activity at the right time.
